DEPARTMENT OF TRANSPORTATION

Quality Assurance and Source Inspection

Contract #: 04-0120F4Cty: SF/ALA Rte: 80 PM: 13.2/13.9File #: 1.28**WELDING INSPECTION REPORT****Resident Engineer:** Siegenthaler, Peter**Address:** 333 Burma Road**City:** Oakland, CA 94607**Report No:** WIR-017339**Date Inspected:** 08-Oct-2010**Project Name:** SAS Superstructure**OSM Arrival Time:** 900**Prime Contractor:** American Bridge/Fluor Enterprises, a JV**OSM Departure Time:** 1730**Contractor:** American Bridge/Fluor Enterprises, a JV**Location:** Job Site

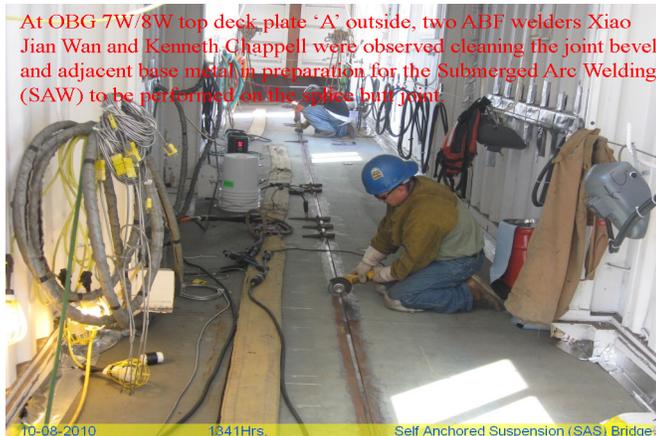
At OBG 7W/8W top deck plate 'A' outside, two ABF welders Xiao Jian Wan and Kenneth Chappell were observed cleaning the joint bevel and adjacent base metal in preparation for the Submerged Arc Welding (SAW) to be performed on the splice butt joint.

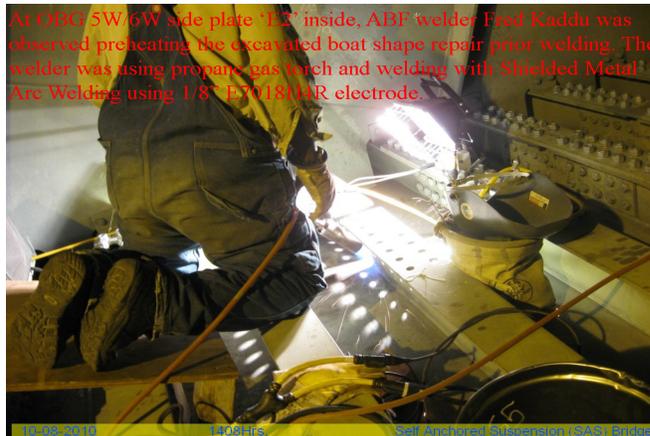
At OBG 5W/6W side plate 'E' inside, ABF welder Fred Kaddu was observed preheating the excavated boat shape repair prior to welding. The welder was using propane gas torch and welding with Shielded Metal Arc Welding using 1/8" E7018 AWS electrode.
