Contract #: 04-0120F4Cty: SF/ALA Rte: 80 PM: 13.2/13.9File #: 69.28**WELDING INSPECTION REPORT****Resident Engineer:** Siegenthaler, Peter**Address:** 333 Burma Road**City:** Oakland, CA 94607**Report No:** WIR-017432**Date Inspected:** 25-Sep-2010**Project Name:** SAS Superstructure**OSM Arrival Time:** 700**Prime Contractor:** American Bridge/Fluor Enterprises, a JV**OSM Departure Time:** 1900**Contractor:** Zhenhua Port Machinery Company, Ltd (ZPMC), Changxing Island **Location:** Shanghai, China**CWI Name:** Qiu Wen**CWI Present:** Yes No**Inspected CWI report:** Yes No N/A**Rod Oven in Use:** Yes No N/A**Electrode to specification:** Yes No N/A**Weld Procedures Followed:** Yes No N/A**Qualified Welders:** Yes No N/A**Verified Joint Fit-up:** Yes No N/A**Approved Drawings:** Yes No N/A**Approved WPS:** Yes No N/A**Delayed / Cancelled:** Yes No N/A**Bridge No:** 34-0006**Component:** Tower & OBG Components**Summary of Items Observed:**

WELDING INSPECTION REPORT

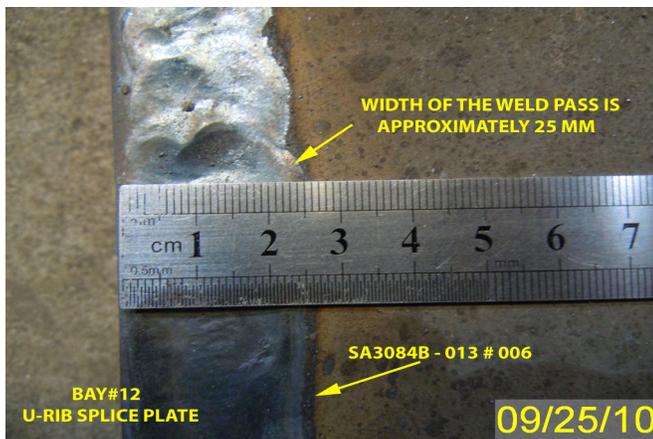
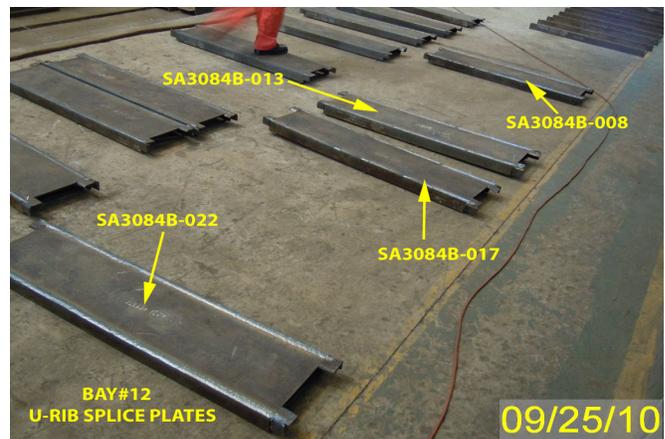
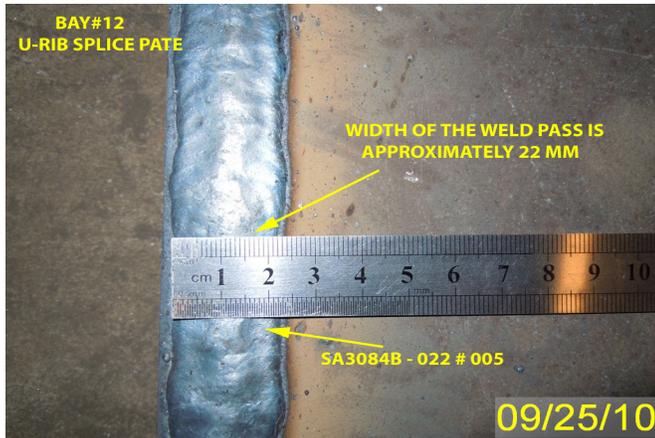
During the Caltrans Quality Assurance (QA) in-process observations of the fabrication of U-Rib Splice Plate, this QA Inspector discovered the following issue:

- ZPMC has performed welding in a manner noncompliant with AWS D1.5 specifications.
- Welding was performed in the 1G (Flat) position using the Flux Cored Arc Welding (FCAW) process.
- AWS D1.5 specifies the maximum single pass width of a groove weld performed in the 1G position using the FCAW process, shall not exceed 16mm.
- This QA measured single pass weld widths from 20mm to 25mm on the following members and welds:
 - 1) SA3084B-022, welds#005; 006.
 - 2) SA3084B-017, welds#005; 006.
 - 3) SA3084B-013, welds#005; 006.
 - 4) SA3084B-008, welds#005; 006.
- The welds are complete joint penetration (CJP) corner joints welded in 1G flat position, using the WPS # WPS-B-T-2231-Tc-U4bF.
- The U-Rib splice plates are located in fabrication Bay#12.

AWS D1.5 2002 section 4.14.1.5 "When the width of a layer of a groove weld in the flat, horizontal, or overhead position is 16 mm [5/8 in.] or greater, a multiple-pass split-layer technique shall be used."

This QA notified ZPMC QC identified as Mr. Zhao Jian Hang and ABF inspector identified as Mr. Peter Ferguson of the above issue and that an incident report will be generated.
