Quality Assurance and Source Inspection

Contract #: 04-0120F4Cty: SF/ALA Rte: 80 PM: 13.2/13.9File #: 1.28**WELDING INSPECTION REPORT****Resident Engineer:** Siegenthaler, Peter**Address:** 333 Burma Road**City:** Oakland, CA 94607**Report No:** WIR-017457**Date Inspected:** 14-Oct-2010**Project Name:** SAS Superstructure**OSM Arrival Time:** 1000**Prime Contractor:** American Bridge/Fluor Enterprises, a JV**OSM Departure Time:** 1830**Contractor:** American Bridge/Fluor Enterprises, a JV**Location:** Job Site**CWI Name:** William Sherwood**CWI Present:** Yes No**Inspected CWI report:** Yes No N/A**Rod Oven in Use:** Yes No N/A**Electrode to specification:** Yes No N/A**Weld Procedures Followed:** Yes No N/A**Qualified Welders:** Yes No N/A**Verified Joint Fit-up:** Yes No N/A**Approved Drawings:** Yes No N/A**Approved WPS:** Yes No N/A**Delayed / Cancelled:** Yes No N/A**Bridge No:** 34-0006**Component:** Orthotropic Box Girder**Summary of Items Observed:**

WELDING INSPECTION REPORT

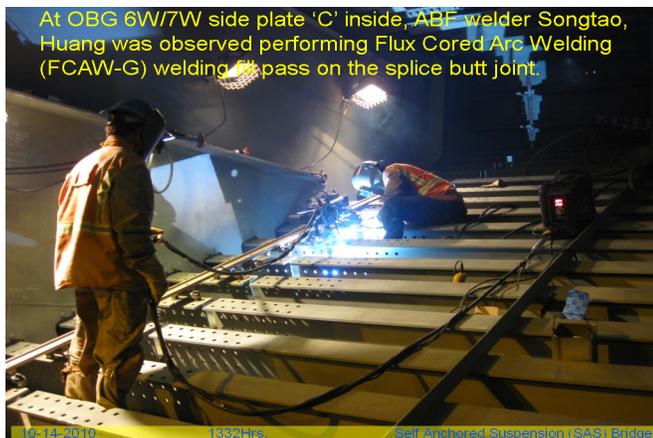
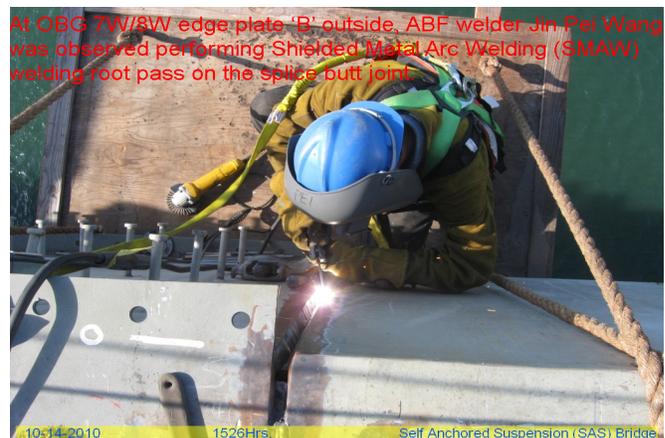
At OBG 6W/7W side plate 'C' (3300mm to 7155mm) inside, QA randomly observed ABF/JV qualified welder Sungtao, Huang ID # 3794 continuing to perform CJP groove (splice) welding fill pass on the splice butt joint. The welder was observed perform automatic welding in the 3G (vertical) position utilizing a dual shield Flux Cored Arc Welding (FCAW-G) with E71T-1M, 1/16" diameter wire electrode and implementing Caltrans approved Welding Procedure Specification (WPS) ABF-WPS-D15-3042A-1. The joint being welded had a single V-groove butt joint with backing bar. The splice joint was preheated and maintained to greater than 150 degrees Fahrenheit using Miller Proheat 35 Induction Heating System heater blankets located at the opposite side of the plate prior/during welding. During welding, ABF Quality Control (QC) William Sherwood was noted monitoring the welding parameters of the welder. At the end of the shift, fill pass welding on the splice butt joint was not completed and should continue tomorrow.

At OBG 7W/8W edge plate 'B' outside, QA randomly observed ABF/JV qualified welder Jin Pei Wang ID #7299 perform root pass welding on the Complete Joint Penetration (CJP) splice butt joint. The welder was observed manually welding in the 3G (vertical) position utilizing a Shielded Metal Arc Welding (SMAW) with 1/8" diameter E7018H4R electrode and implementing Caltrans approved Welding Procedure Specification (WPS) ABF-WPS-D15-1040B. The joint being welded has a single V-groove butt joint with copper backing bar. Prior to start welding, ABF QC William Sherwood was noted measuring the fit up alignment of the joint in which he was

At OBG 7W/8W edge plate 'F' outside, QA randomly observed ABF/JV qualified welder James Zhen ID #6001 perform root pass welding on the Complete Joint Penetration (CJP) splice butt joint. The welder was observed manually welding in the 3G (vertical) position utilizing a Shielded Metal Arc Welding (SMAW) with 1/8" diameter E7018H4R electrode and implementing Caltrans approved Welding Procedure Specification (WPS) ABF-WPS-D15-1040B. The joint being welded has a single V-groove butt joint with copper backing bar. Prior to start welding, ABF QC William Sherwood was noted measuring the fit up alignment of the joint in which he was getting less than 2.0mm misalignment on a 18mm thick plate butt joint. During welding, ABF Quality Control (QC) William Sherwood was noted monitoring the welding parameters of the welder. QA randomly monitored the welding parameter with reading of 135 amperes which appears in conformance to the contract requirements. At the end of the shift, SMAW root welding was still continuing and should continue tomorrow.
