**DEPARTMENT OF TRANSPORTATION**

Contract #: 04-0120F4Cty: SF/ALA Rte: 80 PM: 13.2/13.9File #: 1.28**WELDING INSPECTION REPORT****Resident Engineer:** Siegenthaler, Peter**Address:** 333 Burma Road**City:** Oakland, CA 94607**Report No:** WIR-017481**Date Inspected:** 20-Oct-2010**Project Name:** SAS Superstructure**OSM Arrival Time:** 630**Prime Contractor:** American Bridge/Fluor Enterprises, a JV**OSM Departure Time:** 1500**Contractor:** American Bridge/Fluor Enterprises, a JV**Location:** Jobsite**CWI Name:** See below**CWI Present:** Yes No**Inspected CWI report:** Yes No N/A**Rod Oven in Use:** Yes No N/A**Electrode to specification:** Yes No N/A**Weld Procedures Followed:** Yes No N/A**Qualified Welders:** Yes No N/A**Verified Joint Fit-up:** Yes No N/A**Approved Drawings:** Yes No N/A**Approved WPS:** Yes No N/A**Delayed / Cancelled:** Yes No N/A**Bridge No:** 34-0006**Component:** SAS OBG**Summary of Items Observed:**

# WELDING INSPECTION REPORT

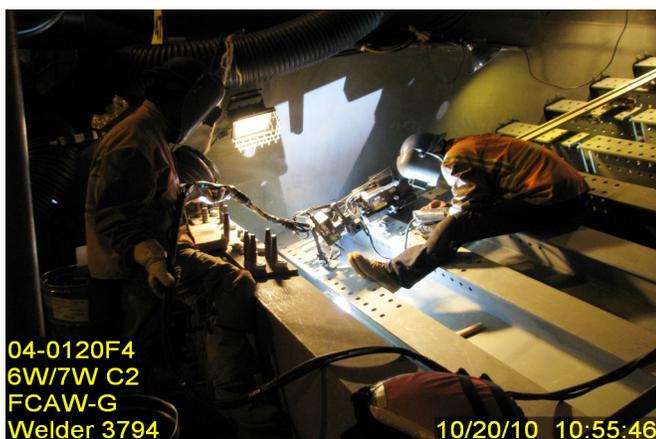
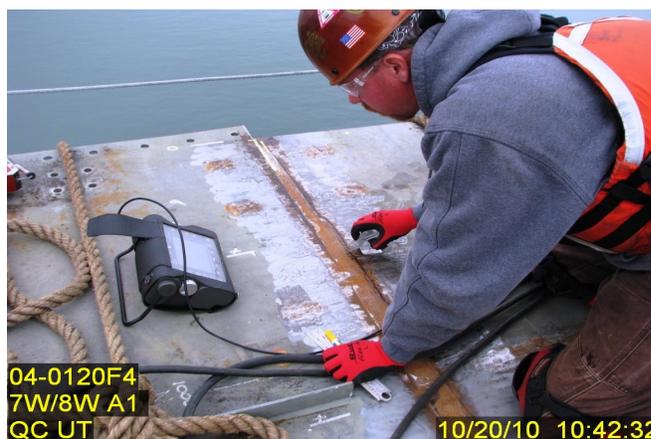
The QAI periodically observed AB/F approved welder Song Tao Huang (ID 3794) assisted by AB/F approved welder Jin Quan Huang, performing welding per the Flux Cored Arc Welding (FCAW-G) process in the 3G (vertical) position of root and fill passes on weld ID: C2. The QAI observed QC Inspector Tony Sherwood was present to monitor the progress and verify that the welding parameters were within the limits established by the approved Welding Procedure Specification (WPS) identified as ABF-WPS-D1.5-3042B-1. The QAI observed as Mr. Sherwood measured the welding parameters and noted the following measurements were obtained: amps = 250, volts = 23.8 and travel speed=328. The QAI calculated the heat input as 1.09 kJ/mm. The QAI observed that the work at this location was in process and appeared to be in general compliance with contract documents. See photo below.

The QAI periodically observed SE QC Inspector Steve McConnell performing UT of OBG Field Splice 7W/8W Weld ID: A1 from the A face. Mr. McConnell utilized the UT Procedure identified as SE-UT-D1.5-CT-100 Rev.4 during the examination of the splice weld. The QC technician performed the required shear wave testing during the testing for weld soundness utilizing a .63 x .75 rectangular transducer. The UT examination was in process during this shift and the QAI observed that the QC inspector had marked several rejectable indications on the steel. See photo below. The QAI also periodically observed SE QC Inspector Tom Pasqualone performing UT of OBG Field Splice 7W/8W Weld ID: A5 from the A face. Mr. Pasqualone utilized the UT Procedure identified as SE-UT-D1.5-CT-100 Rev.4 during the examination of the splice weld. The QC technician performed the required shear wave testing during the testing for weld soundness utilizing a .63 x .75 rectangular transducer. The UT examination was in process during this shift and the QAI observed that the QC inspector had marked several rejectable indications on the steel.
