**DEPARTMENT OF TRANSPORTATION**

Contract #: 04-0120F4Cty: SF/ALA Rte: 80 PM: 13.2/13.9File #: 82.28**WELDING INSPECTION REPORT****Resident Engineer:** Siegenthaler, Peter**Address:** 333 Burma Road**City:** Oakland, CA 94607**Report No:** WIR-017489**Date Inspected:** 12-Oct-2010**Project Name:** SAS Superstructure**OSM Arrival Time:** 700**Prime Contractor:** American Bridge/Fluor Enterprises, a JV**OSM Departure Time:** 1530**Contractor:** Westmont Industries**Location:** Santa Fe Springs, CA.**CWI Name:** R. Rodriguez, R. Dominguez**CWI Present:** Yes No**Inspected CWI report:** Yes No N/A**Rod Oven in Use:** Yes No N/A**Electrode to specification:** Yes No N/A**Weld Procedures Followed:** Yes No N/A**Qualified Welders:** Yes No N/A**Verified Joint Fit-up:** Yes No N/A**Approved Drawings:** Yes No N/A**Approved WPS:** Yes No N/A**Delayed / Cancelled:** Yes No N/A**Bridge No:** 34-0006**Component:** Travelers**Summary of Items Observed:**

# WELDING INSPECTION REPORT

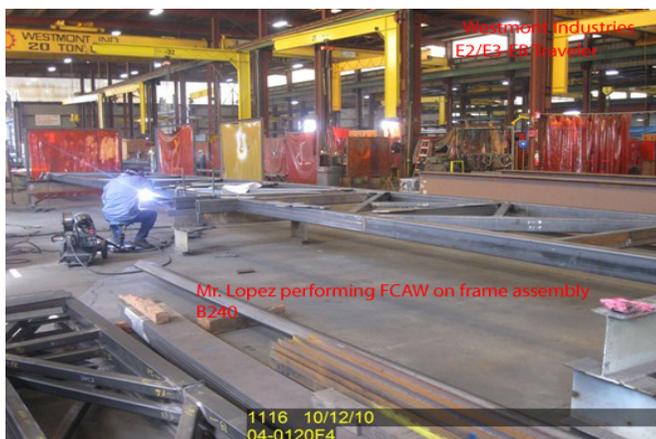
On this date, the QA Inspector observed Westmont Industries (WMI), production welder Eutimo Lopez (WID # 3035), continuing to perform Flux Core Arc Welding (FCAW) activities for the E2/E3-EB Traveler frames. The QA Inspector observed Mr. Lopez performing the FCAW on previously fit and tack welded Tube Steel (TS) and plate material, for the Frame Assembly identified as B240, per the shop drawings. The QA Inspector observed Mr. Lopez perform the FCAW in various positions and observed that Mr. Lopez was performing the FCAW on the fillet and flare groove welds, throughout the shift.

See attached picture below.
