Quality Assurance and Source Inspection

Contract #: 04-0120F4Cty: SF/ALA Rte: 80 PM: 13.2/13.9File #: 82.28**WELDING INSPECTION REPORT****Resident Engineer:** Siegenthaler, Peter**Address:** 333 Burma Road**City:** Oakland, CA 94607**Report No:** WIR-017535**Date Inspected:** 16-Oct-2010**Project Name:** SAS Superstructure**OSM Arrival Time:** 500**Prime Contractor:** American Bridge/Fluor Enterprises, a JV**OSM Departure Time:** 1330**Contractor:** Westmont Industries**Location:** Santa Fe Springs, CA.**CWI Name:** R. Rodriguez, R. Dominguez**CWI Present:** Yes No**Inspected CWI report:** Yes No N/A**Rod Oven in Use:** Yes No N/A**Electrode to specification:** Yes No N/A**Weld Procedures Followed:** Yes No N/A**Qualified Welders:** Yes No N/A**Verified Joint Fit-up:** Yes No N/A**Approved Drawings:** Yes No N/A**Approved WPS:** Yes No N/A**Delayed / Cancelled:** Yes No N/A**Bridge No:** 34-0006**Component:** Travelers**Summary of Items Observed:**

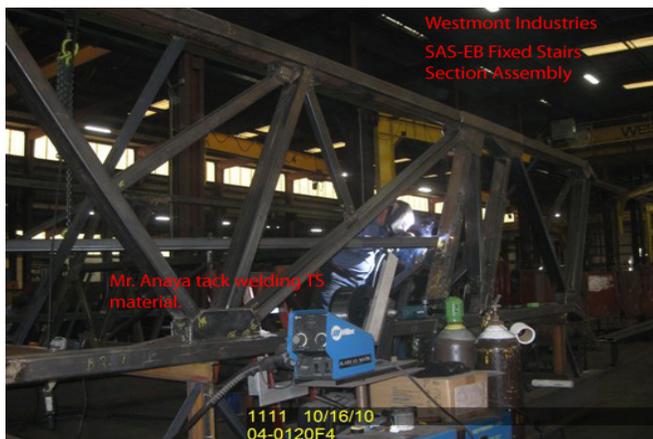
On this date, the QA Inspector observed Westmont Industries (WMI), production personnel Mr. Raymundo Anaya (WID # 3196), Mr. Cesar Canales and Mr. Jose Rodriguez (WID # 3031), continuing to perform fitting and Flux Core Arc Welding (FCAW) activities for the fabrication of the Fixed Stairs Section Assembly. The QA Inspector observed that the activities were being performed on the previously placed and fit Frame Assemblies, identified as A237, B237, A218, A219 and A223. The QA Inspector observed Mr. Anaya and Canales occasionally reference the shop drawings and then fit and tack weld various pieces of previously cut material including Tube Steel (TS) and connector plates. After the material was fit and tacked, the QA Inspector observed that Smith Emery QC

Inspector Mr. Ruben Dominguez was present to verify the fit up. After the fit up was verified, the QA Inspector observed Mr. Rodriguez then perform the FCAW activities in various positions on these weld joints, designated as fillet and flare groove.

See attached picture below.
