**DEPARTMENT OF TRANSPORTATION**

Contract #: 04-0120F4Cty: SF/ALA Rte: 80 PM: 13.2/13.9File #: 69.28**WELDING INSPECTION REPORT****Resident Engineer:** Siegenthaler, Peter**Address:** 333 Burma Road**City:** Oakland, CA 94607**Report No:** WIR-017539**Date Inspected:** 12-Oct-2010**Project Name:** SAS Superstructure**OSM Arrival Time:** 700**Prime Contractor:** American Bridge/Fluor Enterprises, a JV**OSM Departure Time:** 1900**Contractor:** Zhenhua Port Machinery Company, Ltd (ZPMC), Changxing Island **Location:** Shanghai, China**CWI Name:** Qiu Wen**CWI Present:** Yes No**Inspected CWI report:** Yes No N/A**Rod Oven in Use:** Yes No N/A**Electrode to specification:** Yes No N/A**Weld Procedures Followed:** Yes No N/A**Qualified Welders:** Yes No N/A**Verified Joint Fit-up:** Yes No N/A**Approved Drawings:** Yes No N/A**Approved WPS:** Yes No N/A**Delayed / Cancelled:** Yes No N/A**Bridge No:** 34-0006**Component:** OBG Components**Summary of Items Observed:**

ORTHOTROPIC BOX GIRDER (OBG) AT BAY#10

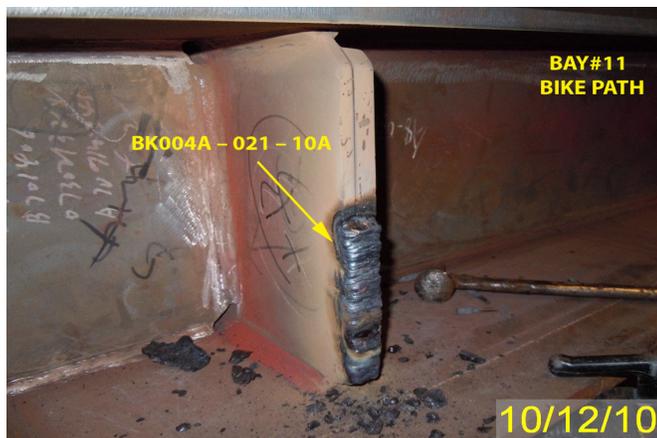
Surface welding / buttering being performed as per the weld repair report B-WR14884 located on bike path stringer plate, BK004A – 021 – 10A. Welder is identified as 040655. ZPMC Quality Control (QC) Inspector is

identified as Shang Hai Lang. The welding variables recorded by QC appeared to comply with the WPS – 345 – SMAW – 3G (3F) – Repair. (See attached photo)

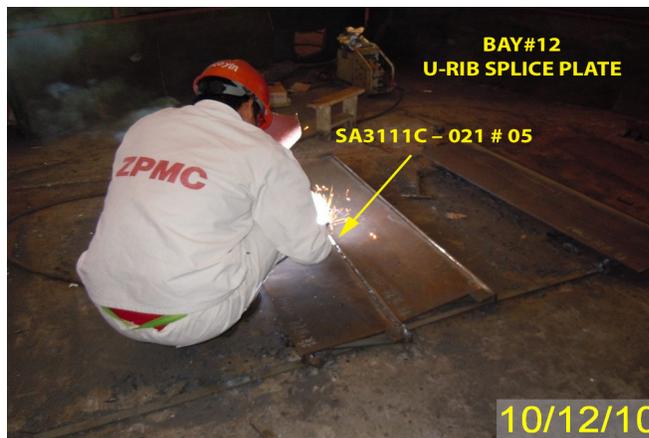
Weld joint # 05 located on U-rib splice plate SA3111C – 021. Welder is identified as 059403. ZPMC Quality Control (QC) Inspector is identified as Zhao Jian Hang. The welding variables recorded by QC appeared to comply with the WPS – B – T – 2231 – Tc – U4b – F. (See attached photo)
