DEPARTMENT OF TRANSPORTATION

Contract #: 04-0120F4Cty: SF/Ala Rte: 80 PM: 13.2/13.9File #: 69.28**WELDING INSPECTION REPORT****Resident Engineer:** Siegenthaler, Peter**Address:** 333 Burma Road**City:** Oakland, CA 94607**Report No:** WIR-017552**Date Inspected:** 03-Oct-2010**Project Name:** SAS Superstructure**OSM Arrival Time:** 1900**Prime Contractor:** American Bridge/Fluor Enterprises, a JV**OSM Departure Time:** 700**Contractor:** Zhenhua Port Machinery Company, Ltd (ZPMC), Changxing Island **Location:** Shanghai, China**CWI Name:** See below**CWI Present:** Yes No**Inspected CWI report:** Yes No N/A**Rod Oven in Use:** Yes No N/A**Electrode to specification:** Yes No N/A**Weld Procedures Followed:** Yes No N/A**Qualified Welders:** Yes No N/A**Verified Joint Fit-up:** Yes No N/A**Approved Drawings:** Yes No N/A**Approved WPS:** Yes No N/A**Delayed / Cancelled:** Yes No N/A**Bridge No:** 34-0006**Component:** Tower and OBG Components**Summary of Items Observed:**

WELDING INSPECTION REPORT

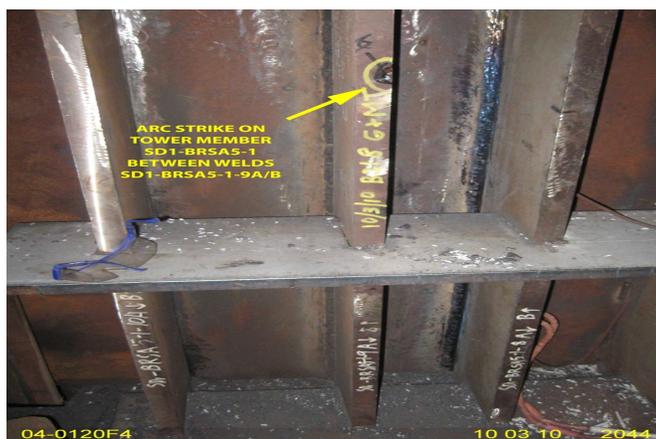
During random in process inspection of tower member identified as SD1-BRSA5-1 this QA Inspector observed an arc strike on the edge of the stiffener between the welds marked as SD1-BRSA5-1-9A/B located on PCMK SD1-BRSA5-1-BR5-5. The arc strike had been marked in black ink with the letter G only, signifying 'grind smooth'. This QA Inspector clearly marked the visual indication in yellow paint with G+MT, signifying 'grind smooth and magnetic particle test'. See the photo below. This QA Inspector also notified QCA2 of the arc strike. QCA2 informed this QA Inspector that the arc strike would be corrected in a manner compliant with the contract documents.
