**DEPARTMENT OF TRANSPORTATION**

Quality Assurance and Source Inspection

Contract #: 04-0120F4Cty: SF/ALA Rte: 80 PM: 13.2/13.9File #: 69.28**WELDING INSPECTION REPORT****Resident Engineer:** Siegenthaler, Peter**Address:** 333 Burma Road**City:** Oakland, CA 94607**Report No:** WIR-017581**Date Inspected:** 19-Oct-2010**Project Name:** SAS Superstructure**OSM Arrival Time:** 700**Prime Contractor:** American Bridge/Fluor Enterprises, a JV**OSM Departure Time:** 1900**Contractor:** Zhenhua Port Machinery Company, Ltd (ZPMC), Changxing Island **Location:** Shanghai, China**CWI Name:** Mr. Qiu Wen.**CWI Present:** Yes No**Inspected CWI report:** Yes No N/A**Rod Oven in Use:** Yes No N/A**Electrode to specification:** Yes No N/A**Weld Procedures Followed:** Yes No N/A**Qualified Welders:** Yes No N/A**Verified Joint Fit-up:** Yes No N/A**Approved Drawings:** Yes No N/A**Approved WPS:** Yes No N/A**Delayed / Cancelled:** Yes No N/A**Bridge No:** 34-0006**Component:** Tower and Orthotropic Box Girder (OBG)**Summary of Items Observed:**

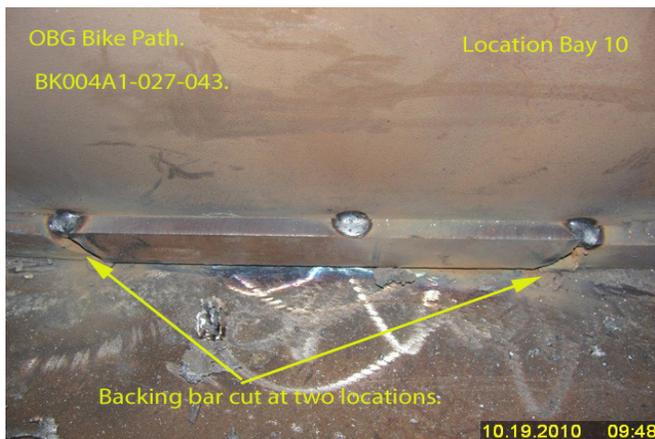
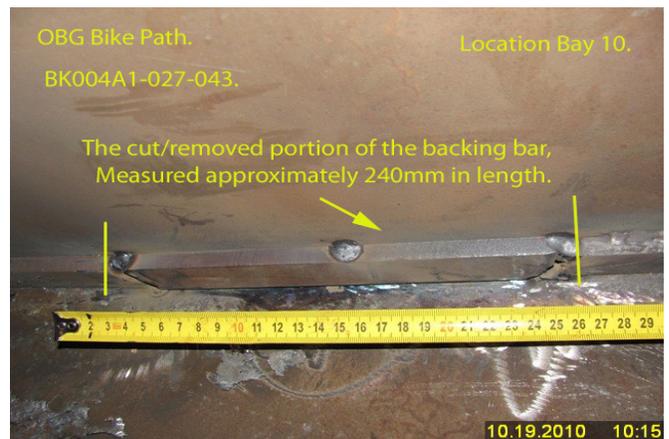
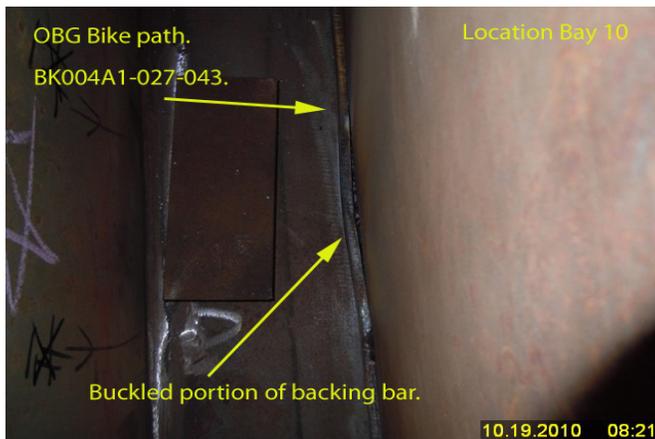
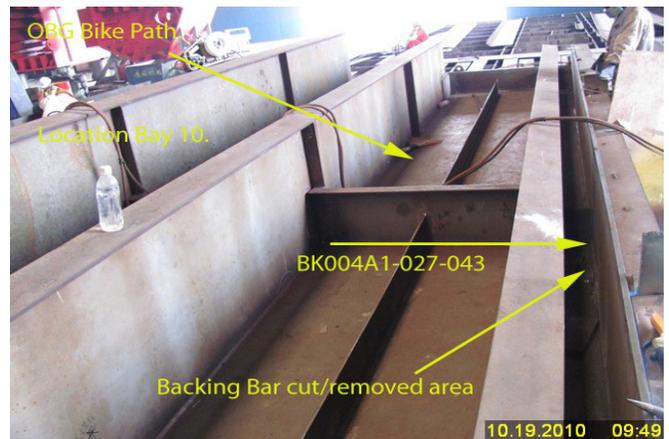
BK004A-027, this Quality Assurance Inspector (QA) discovered the following issue, ZPMC personnel removed and replaced a buckled portion of a welded backing bar without Engineers approval. The removed backing bar portion was 240mm in length. AWS D1.5 specifies steel backing shall be continuous for the full length of the each weld made with backing. The weld is identified as: BK004A1-027-043. The effected weld is complete joint penetration (CJP) with backing bar plate. The material thickness for this backing bar plate is 10 mm. This OBG Bike Path is located in Sub assembly Bay #10. This QA inspector generated incident report for this date. For further information, please see the attached pictures below.
