Contract #: 04-0120F4Cty: SF/ALA Rte: 80 PM: 13.2/13.9File #: 82.28**WELDING INSPECTION REPORT****Resident Engineer:** Siegenthaler, Peter**Address:** 333 Burma Road**City:** Oakland, CA 94607**Report No:** WIR-017605**Date Inspected:** 20-Oct-2010**Project Name:** SAS Superstructure**OSM Arrival Time:** 700**Prime Contractor:** American Bridge/Fluor Enterprises, a JV**OSM Departure Time:** 1530**Contractor:** Westmont Industries**Location:** Santa Fe Springs, CA.**CWI Name:** R. Rodriguez, R. Dominguez**CWI Present:** Yes No**Inspected CWI report:** Yes No N/A**Rod Oven in Use:** Yes No N/A**Electrode to specification:** Yes No N/A**Weld Procedures Followed:** Yes No N/A**Qualified Welders:** Yes No N/A**Verified Joint Fit-up:** Yes No N/A**Approved Drawings:** Yes No N/A**Approved WPS:** Yes No N/A**Delayed / Cancelled:** Yes No N/A**Bridge No:** 34-0006**Component:** Travelers**Summary of Items Observed:**

SAS-EB Traveler**Fixed Stairs Section**

WELDING INSPECTION REPORT

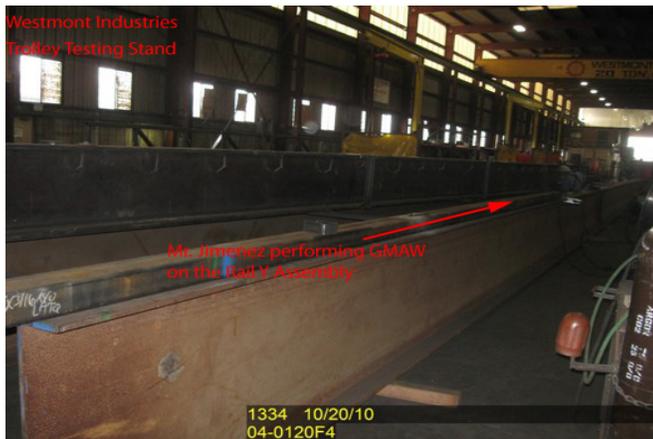
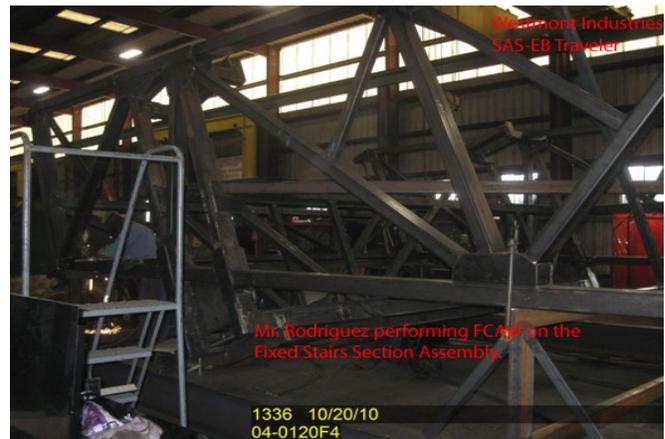
On this date, the QA Inspector observed Westmont Industries (WMI), production personnel Mr. Raymundo Anaya (WID # 3196), Mr. Cesar Canales and Mr. Jose Rodriguez (WID # 3031), continuing to perform fitting and Flux Core Arc Welding (FCAW) activities for the fabrication of the Fixed Stairs Section Assembly. The QA Inspector observed that the activities were being performed on the previously placed and fit Frame Assemblies, identified as A237, B237, A218, A219 and A223. The QA Inspector observed Mr. Anaya and Canales occasionally reference the shop drawings and then fit and tack weld various pieces of previously cut material, including Tube Steel (TS) and connector plates. The QA Inspector observed that Mr. Anaya and Rodriguez were performing the FCAW in

various positions throughout the shift.

See attached picture below.
