**DEPARTMENT OF TRANSPORTATION**

Contract #: 04-0120F4Cty: SF/ALA Rte: 80 PM: 13.2/13.9File #: 82.28**WELDING INSPECTION REPORT****Resident Engineer:** Siegenthaler, Peter**Address:** 333 Burma Road**City:** Oakland, CA 94607**Report No:** WIR-017623**Date Inspected:** 21-Oct-2010**Project Name:** SAS Superstructure**Prime Contractor:** American Bridge/Fluor Enterprises, a JV**Contractor:** Westmont Industries**OSM Arrival Time:** 700**OSM Departure Time:** 1530**Location:** Santa Fe Springs, CA.

**Summary of Items Observed:**

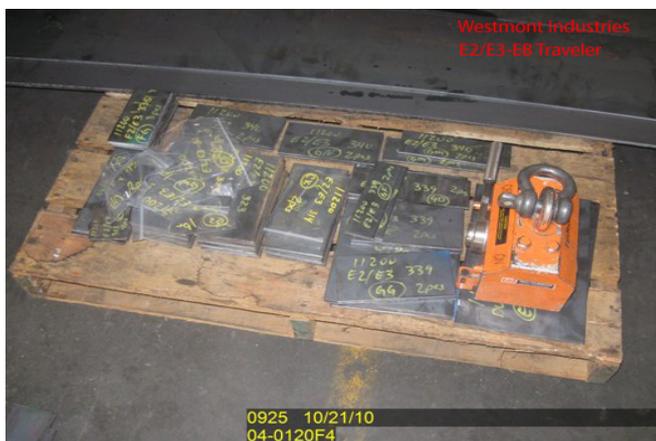
The QA Inspector observed WMI production personnel, Mr. Ruiz Villasenor, continuing to utilize the Pearson shear to cut plate material. The QA Inspector observed that the material being cut, appeared to material which will be utilized for the fabrication of the E2/E3-EB Traveler. The QA Inspector randomly observed that Mr. Villasenor had copies of the shop drawings and appeared to reference the Bill of Material list, to cut the material to the specific dimensions. Once the material was cut, the QA Inspector observed Mr. Villasenor utilize a paint stick marker to identify each piece of plate material per the piece mark and job #. The QA Inspector observed that the above mentioned plate material had been previously inspected, the MTR's had been previously provided and the QA Inspector had previously written "OK to Cut", on the plate material.

fitting and tacking, activities for the E2/E3-EB Traveler frame assemblies. The QA Inspector observed Mr. Anaya initially fit previous cut to length Tube Steel (TS) material. Once fit the QA Inspector observed Mr. Anaya perform dimensional checks on the fit material and then perform the FCAW tacking. The QA Inspector observed that the frame assemblies appeared to be identified as A317, A324 and A323, per the shop drawings. The QA Inspector observed that Smith-Emery QC Inspector Ruben Dominguez was present, during the above mentioned welding and tacking activities and QC Inspector Dominguez explained that approved Welding Procedure Specifications (WPS's) were being utilized. The QA Inspector randomly observed that the applicable WPS's and copies of the shop drawings, were located near each work station, where the above mentioned FCAW and fitting activities were being performed. The QA Inspector randomly verified that the consumable material, utilized during the welding was in compliance to the applicable WPS and that the above mentioned welders were currently qualified for the applicable process and position of welding. The QA Inspector randomly observed QC Inspector Dominguez verifying the in-process welding parameters, including voltage, amperage, pre-heat and travel speed and the parameters appeared to be in compliance to the applicable WPS.

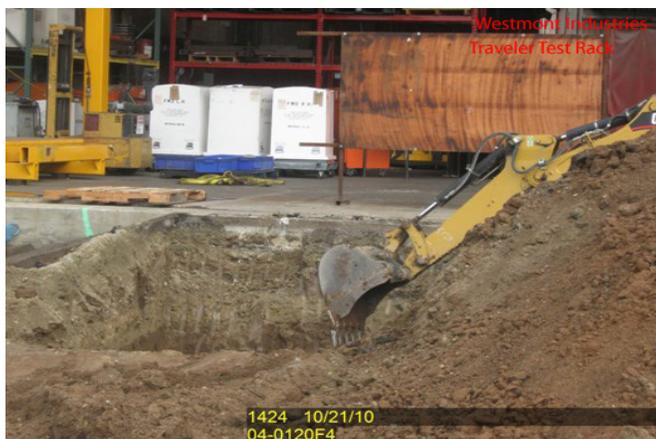
On this date, the QA Inspector was informed by WMI QCM Rick Rodriguez that the earth excavation had started, in preparation for the Traveler Testing Rack concrete footings. See attached picture below.
