Contract #: 04-0120F4Cty: SF/ALA Rte: 80 PM: 13.2/13.9File #: 69.28**WELDING INSPECTION REPORT****Resident Engineer:** Siegenthaler, Peter**Address:** 333 Burma Road**City:** Oakland, CA 94607**Report No:** WIR-017640**Date Inspected:** 13-Sep-2010**Project Name:** SAS Superstructure**OSM Arrival Time:** 1100**Prime Contractor:** American Bridge/Fluor Enterprises, a JV**OSM Departure Time:** 2300**Contractor:** Zhenhua Port Machinery Company, Ltd (ZPMC), Changxing Island **Location:** Shanghai, China**CWI Name:** Wang Jie**CWI Present:** Yes No**Inspected CWI report:** Yes No N/A**Rod Oven in Use:** Yes No N/A**Electrode to specification:** Yes No N/A**Weld Procedures Followed:** Yes No N/A**Qualified Welders:** Yes No N/A**Verified Joint Fit-up:** Yes No N/A**Approved Drawings:** Yes No N/A**Approved WPS:** Yes No N/A**Delayed / Cancelled:** Yes No N/A**Bridge No:** 34-0006**Component:** OBG**Summary of Items Observed:**

BAY 04, DECK PANEL (NWIT # 06658)

## WELDING INSPECTION REPORT

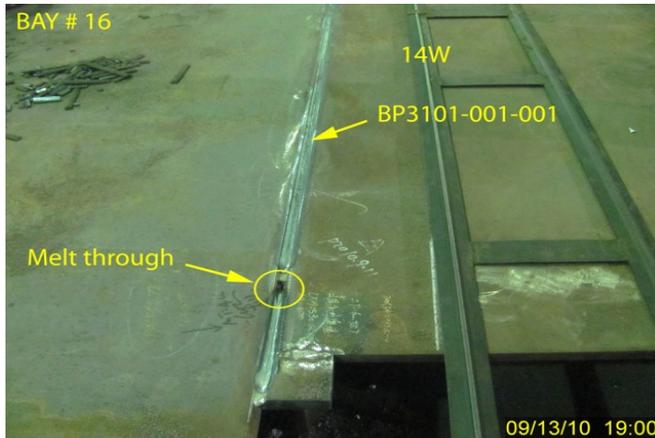
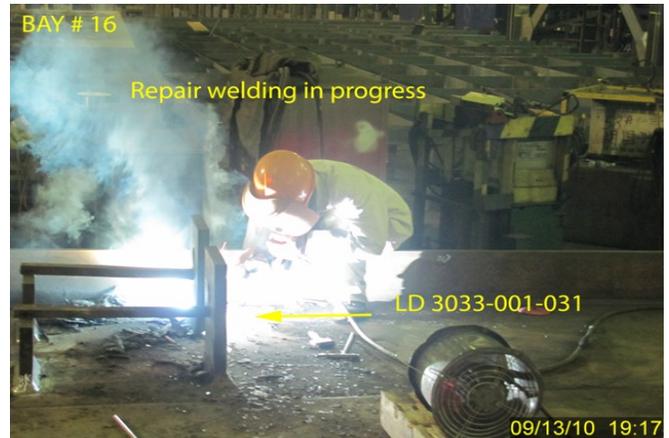
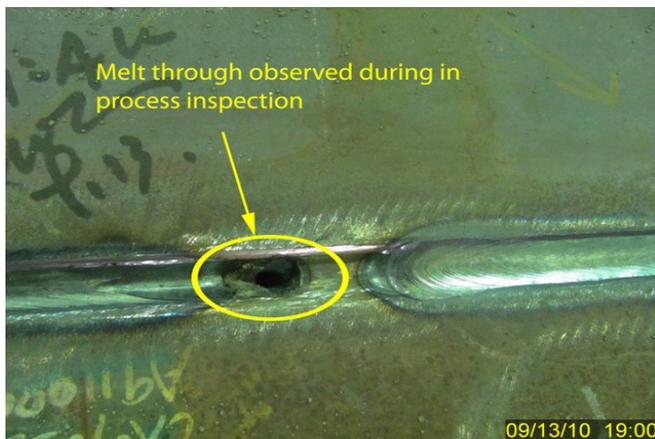
During random in process inspection this QA inspector observed the melt through on the weld during SAW welding of the weld joint BP3101-001-001. This issue has been discussed with ZPMC CWI Mr. Wang Jie, and as per conversation ZPMC agreed to perform the repair and required NDT prior, during and after welding on specific locations as per repair procedure.
