Contract #: 04-0120F4Cty: SF/ALA Rte: 80 PM: 13.2/13.9File #: 82.28**WELDING INSPECTION REPORT****Resident Engineer:** Siegenthaler, Peter**Address:** 333 Burma Road**City:** Oakland, CA 94607**Report No:** WIR-017689**Date Inspected:** 29-Oct-2010**Project Name:** SAS Superstructure**OSM Arrival Time:** 700**Prime Contractor:** American Bridge/Fluor Enterprises, a JV**OSM Departure Time:** 1530**Contractor:** Westmont Industries**Location:** Santa Fe Springs, CA.**CWI Name:** Ruben Dominguez**CWI Present:** Yes No**Inspected CWI report:** Yes No N/A**Rod Oven in Use:** Yes No N/A**Electrode to specification:** Yes No N/A**Weld Procedures Followed:** Yes No N/A**Qualified Welders:** Yes No N/A**Verified Joint Fit-up:** Yes No N/A**Approved Drawings:** Yes No N/A**Approved WPS:** Yes No N/A**Delayed / Cancelled:** Yes No N/A**Bridge No:** 34-0006**Component:** Travelers**Summary of Items Observed:**

WELDING INSPECTION REPORT

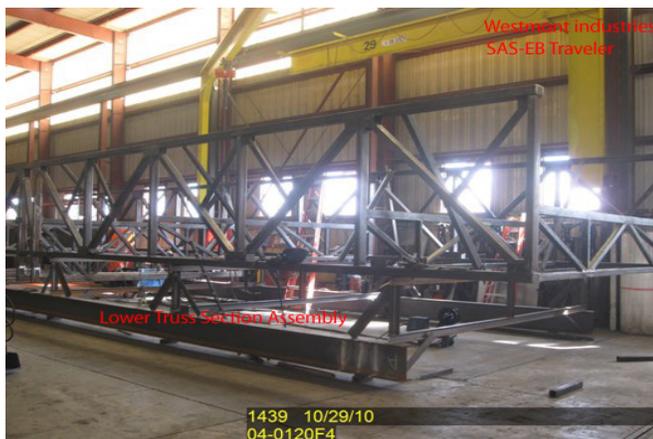
Lower Truss Section

On this date, the QA Inspector observed Westmont Industries (WMI) production personnel Mr. Eutimo Lopez, Mr. Cesar Canales and a helper fitting the previously completed Frame assemblies, for the SAS-EB Lower Truss Section.

The QA Inspector observed that the Frame assemblies had been previously lifted and placed and appeared to be identified as A240, B240, A225 and A230, per the assembly #, which appeared to have been previously written on the Frame assemblies. The QA Inspector observed throughout the shift, that the FCAW was being performed in various positions, on the connector plate and Tube Steel (TS) material fillet and flare groove welds.

See attached picture below.
