**DEPARTMENT OF TRANSPORTATION**

Contract #: 04-0120F4Cty: SF/ALA Rte: 80 PM: 13.2/13.9File #: 1.28**WELDING INSPECTION REPORT****Resident Engineer:** Siegenthaler, Peter**Address:** 333 Burma Road**City:** Oakland, CA 94607**Report No:** WIR-017690**Date Inspected:** 27-Oct-2010**Project Name:** SAS Superstructure**OSM Arrival Time:** 730**Prime Contractor:** American Bridge/Fluor Enterprises, a JV**OSM Departure Time:** 1600**Contractor:** American Bridge/Fluor Enterprises, a JV**Location:** Job Site**CWI Name:** William Norris**CWI Present:** Yes No**Inspected CWI report:** Yes No N/A**Rod Oven in Use:** Yes No N/A**Electrode to specification:** Yes No N/A**Weld Procedures Followed:** Yes No N/A**Qualified Welders:** Yes No N/A**Verified Joint Fit-up:** Yes No N/A**Approved Drawings:** Yes No N/A**Approved WPS:** Yes No N/A**Delayed / Cancelled:** Yes No N/A**Bridge No:** 34-0006**Component:** S.A.S. components**Summary of Items Observed:**

# WELDING INSPECTION REPORT

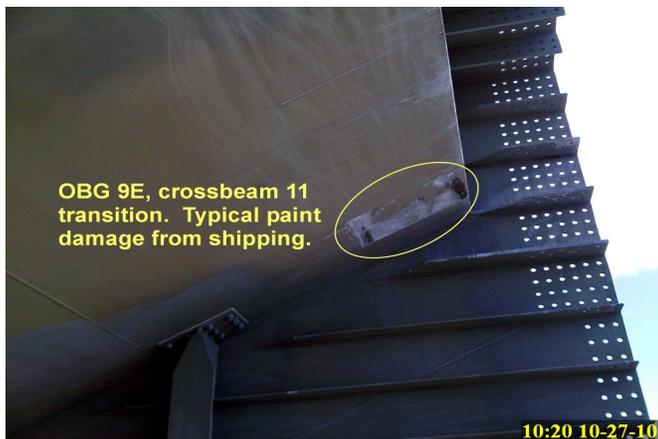
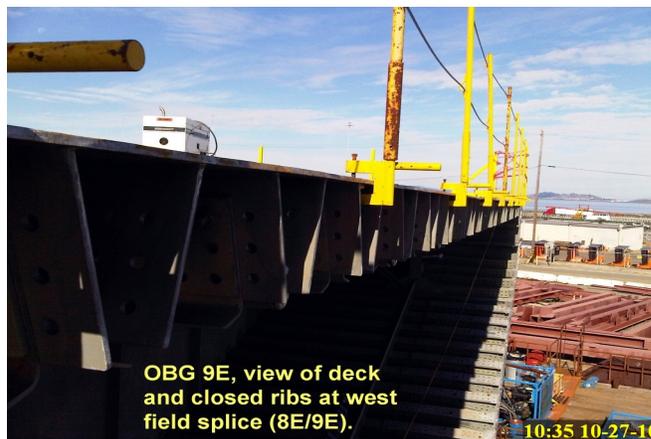
The QAI accompanied Caltrans personnel Jason Wilcox, Philip He, ABF representative Chuck Kanapicki and Quality Control (QC) Inspector William Norris in conducting the post arrival inspection of voyage 5 OBG components. During the inspection of OBG 9E, the QAI noted that painted surfaces have been marred from general shipping and handling. There was no other shipping related damage observed during this inspection. The QAI noted that the only part examined during this post arrival inspection is OBG 9E. The QAI noted that at this time, OBG 9W is not ready for post arrival inspection and the contractor's personnel are working to remove the temporary shipping braces. The QAI was informed that additional post arrival inspections will be scheduled when ready. See the attached photos.
