**DEPARTMENT OF TRANSPORTATION**

Contract #: 04-0120F4Cty: SF/ALA Rte: 80 PM: 13.2/13.9File #: 69.28**WELDING INSPECTION REPORT****Resident Engineer:** Siegenthaler, Peter**Address:** 333 Burma Road**City:** Oakland, CA 94607**Report No:** WIR-017716**Date Inspected:** 18-Oct-2010**Project Name:** SAS Superstructure**OSM Arrival Time:** 700**Prime Contractor:** American Bridge/Fluor Enterprises, a JV**OSM Departure Time:** 1900**Contractor:** Zhenhua Port Machinery Company, Ltd (ZPMC), Changxing Island **Location:** Shanghai, China**CWI Name:** Xu Le Feng**CWI Present:** Yes No**Inspected CWI report:** Yes No N/A**Rod Oven in Use:** Yes No N/A**Electrode to specification:** Yes No N/A**Weld Procedures Followed:** Yes No N/A**Qualified Welders:** Yes No N/A**Verified Joint Fit-up:** Yes No N/A**Approved Drawings:** Yes No N/A**Approved WPS:** Yes No N/A**Delayed / Cancelled:** Yes No N/A**Bridge No:** 34-0006**Component:** TOWER & OBG Components**Summary of Items Observed:**

**ORTHOTROPIC BOX GIRDER (OBG) AT BAY#11**

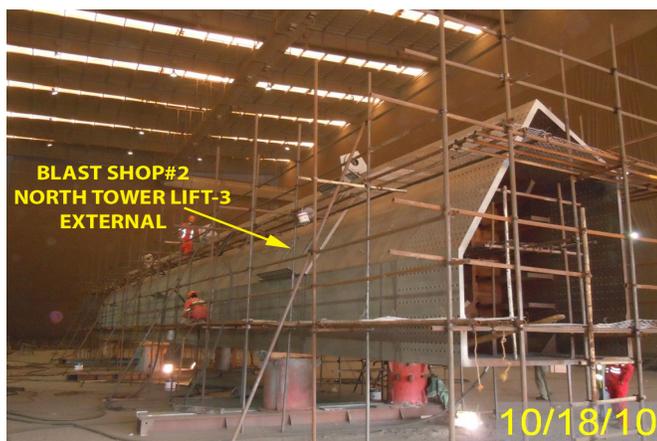
- Two (2) areas that required further grinding/welding at skins A, B, C, D, & E of North Shaft, Lift 3:
  - a. Cluster of Porosity found at 108.58 metre elevation on the doubler plate of Skin E.
  - b. Base metal cavity found at 114 metre elevation on Skin E, Edge- Top side. This is approx. 755 mm from Skin A/E corner. (See attached photos)
