DEPARTMENT OF TRANSPORTATION

Quality Assurance and Source Inspection

Contract #: 04-0120F4Cty: SF/ALA Rte: 80 PM: 13.2/13.9File #: 69.28**WELDING INSPECTION REPORT****Resident Engineer:** Siegenthaler, Peter**Address:** 333 Burma Road**City:** Oakland, CA 94607**Report No:** WIR-017764**Date Inspected:** 24-Oct-2010**Project Name:** SAS Superstructure**OSM Arrival Time:** 700**Prime Contractor:** American Bridge/Fluor Enterprises, a JV**OSM Departure Time:** 1900**Contractor:** Zhenhua Port Machinery Company, Ltd (ZPMC), Changxing Island **Location:** Shanghai, China

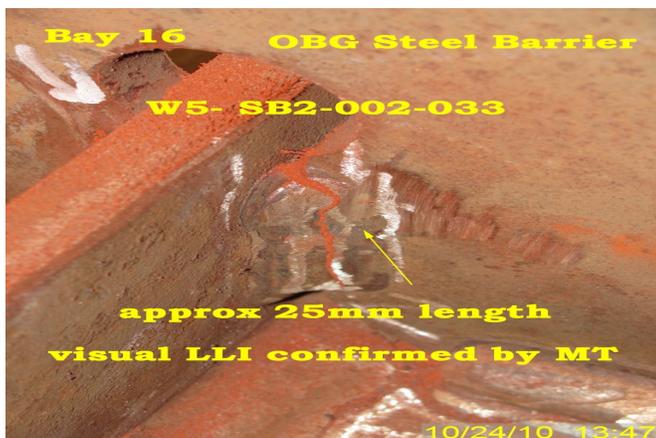
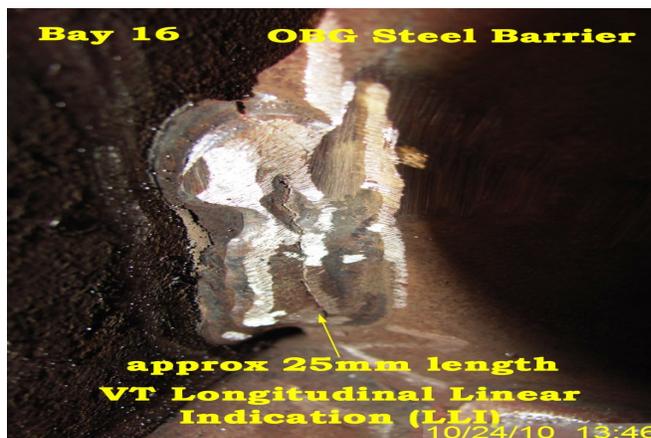
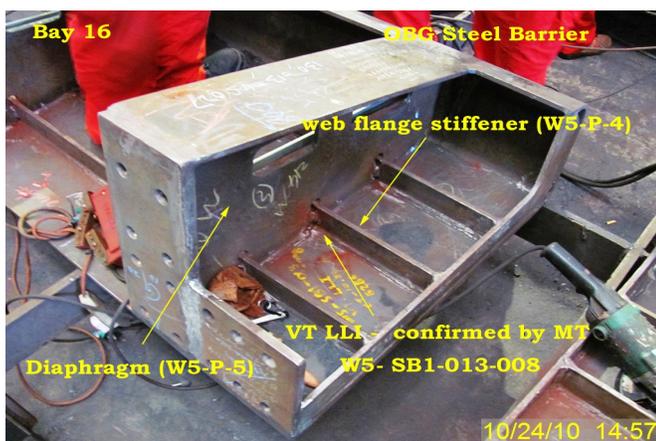
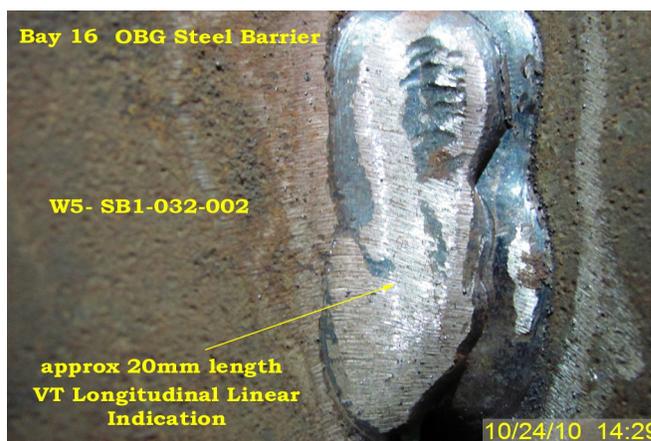
During random Quality Assurance visual verification of welds located on OBG Component steel barrier, Caltrans (CT) Quality Assurance Inspectors (QA) discovered the following issues:

- Four (4) Longitudinal Linear Indications with each measuring approximately 20 to 25mm in length.

- The indications were found on barriers identified as W5- SB1-013-008, W5- SB1-032-002, W5- SB1-029-042, and W5- SB2-002-033.
- These welds are fillet weld joints, joining the diaphragm (W5-P-5) to web flange stiffener (W5-P-4).
- The diaphragm to web flange stiffener is identified as non Seismic Performance Critical Member (non SPCM).
- The indications are clearly marked on the material near the weld.
- OBG Component Steel barriers are located in Bay#16.
- The indications were discovered visually and confirmed by Magnetic particle Testing (MT) by Caltrans QA

The Notice of Witness Inspection Number (NWIT) is 007081. The Longitudinal Linear Indications are located within an area that had been previously inspected by ZPMC Quality Control (QC) personnel. As per contract documents ZPMC is required to perform 100% Visual Testing (VT) of these welds.
