Quality Assurance and Source Inspection

Contract #: 04-0120F4Cty: SF/ALA Rte: 80 PM: 13.2/13.9File #: 69.28**WELDING INSPECTION REPORT****Resident Engineer:** Siegenthaler, Peter**Address:** 333 Burma Road**City:** Oakland, CA 94607**Report No:** WIR-017873**Date Inspected:** 23-Sep-2010**Project Name:** SAS Superstructure**OSM Arrival Time:** 700**Prime Contractor:** American Bridge/Fluor Enterprises, a JV**OSM Departure Time:** 1900**Contractor:** Zhenhua Port Machinery Company, Ltd (ZPMC), Changxing Island **Location:** Shanghai, China**CWI Name:** Gong Wai**CWI Present:** Yes No**Inspected CWI report:** Yes No N/A**Rod Oven in Use:** Yes No N/A**Electrode to specification:** Yes No N/A**Weld Procedures Followed:** Yes No N/A**Qualified Welders:** Yes No N/A**Verified Joint Fit-up:** Yes No N/A**Approved Drawings:** Yes No N/A**Approved WPS:** Yes No N/A**Delayed / Cancelled:** Yes No N/A**Bridge No:** 34-0006**Component:** OBG COMPONENT**Summary of Items Observed:**

WELDING INSPECTION REPORT

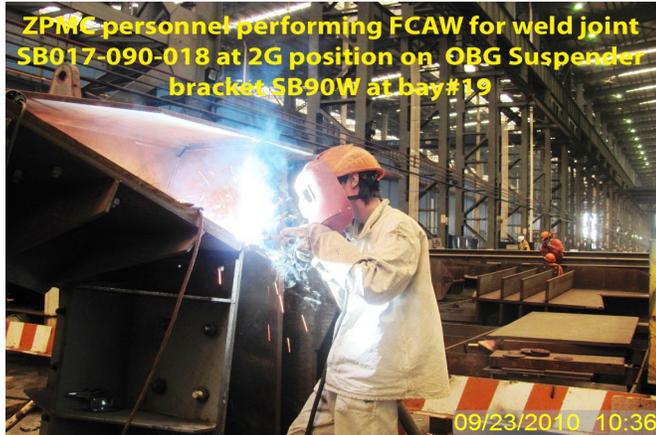
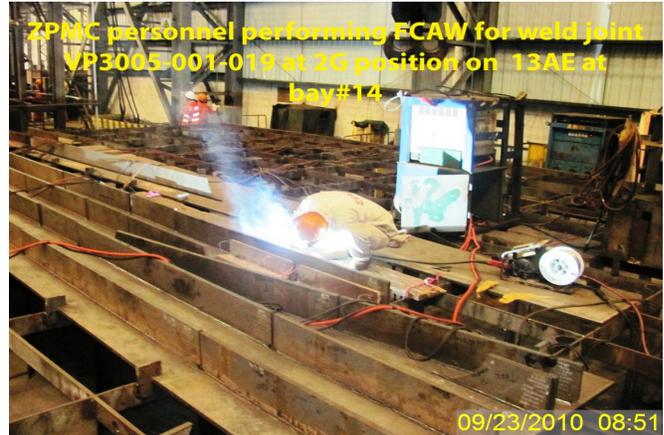
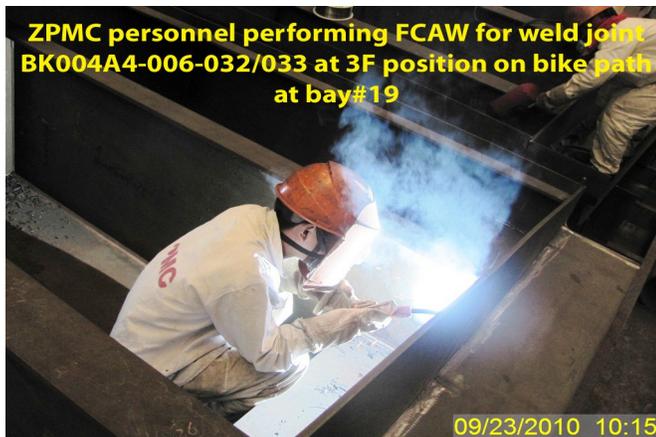
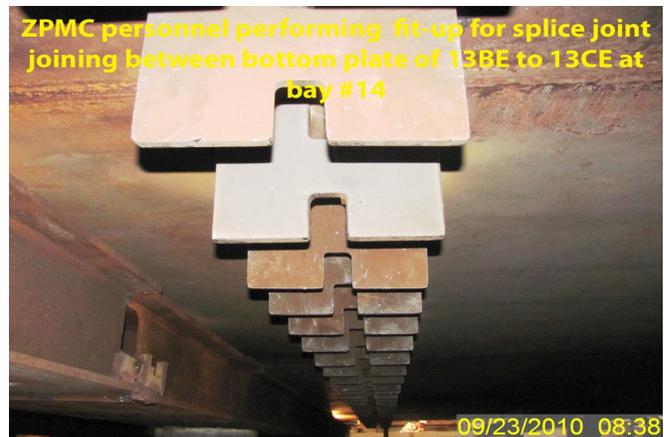
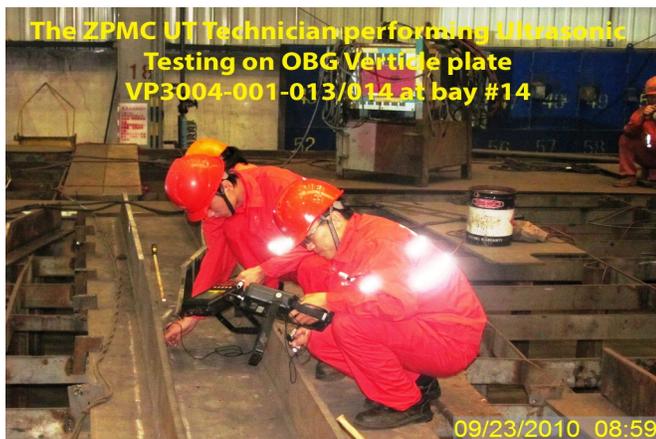
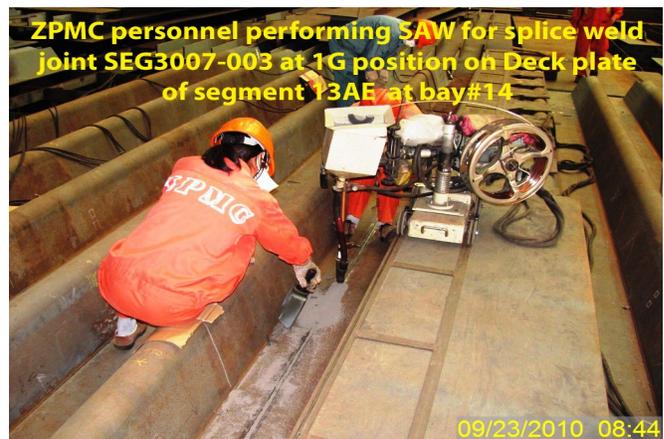
This QA Inspector observed the following work in progress:

SMAW in the 4G position for the OBG segment 12AW, VT repair weld No. SEG3004AL-020. The welder is identified as #051348. ZPMC QC is identified as Mr. Wu Shi Gao. The welding variables recorded by QC appear to comply with WPS-345-SMAW-4G(4F)-FCM-repair.

FCAW in the 2G position for the OBG segment 13AE, weld No.VP3005-001-019. The welder is identified as #066439. ZPMC QC is identified as Mr.Zhang Guo Hui. The welding variables recorded by QC appear to comply with WPS-B-T-2232-Tc-U4B-F.

SAW in the 1G position for the OBG segment 13AE, weld No. SEG3007-003. The welder is identified as #044771. ZPMC QC is identified as Mr.Wang Xu. The welding variables recorded by QC appear to comply with WPS-B-T-2221-B-L2c-S-2.

FCAW in the 3F position for the OBG bike path, weld No. BK004A4-006-032/033. The welder is identified as #062755. ZPMC QC is identified as Mr.Xu Tao. The welding variables recorded by QC appear to comply with WPS-B-T-2133.

This Quality Assurance (QA) Inspector performed Visual inspection and verification of Magnetic Particle Testing (MT) 15% for OBG Cross Beam CB16 weld. This QA inspector generated a (MT) report for this date .This area was previously tested and accepted by ZPMC QC MT technicians.

This Quality Assurance (QA) Inspector performed random visual inspection of OBG segment 11CW internal side panel, edge panel and bottom panel surfaces after grit blasting in between PP102 to PP103.5. Areas that marked

for repair were recorded for future repair. Areas requiring additional grinding were marked by QA and repaired by ZPMC personnel.
