DEPARTMENT OF TRANSPORTATION

Quality Assurance and Source Inspection

Contract #: 04-0120F4Cty: SF/ALA Rte: 80 PM: 13.2/13.9File #: 82.28**WELDING INSPECTION REPORT****Resident Engineer:** Siegenthaler, Peter**Address:** 333 Burma Road**City:** Oakland, CA 94607**Report No:** WIR-017882**Date Inspected:** 30-Oct-2010**Project Name:** SAS Superstructure**OSM Arrival Time:** 500**Prime Contractor:** American Bridge/Fluor Enterprises, a JV**OSM Departure Time:** 1330**Contractor:** Westmont Industries**Location:** Santa Fe Springs, CA.**CWI Name:** Ruben Dominguez**CWI Present:** Yes No**Inspected CWI report:** Yes No N/A**Rod Oven in Use:** Yes No N/A**Electrode to specification:** Yes No N/A**Weld Procedures Followed:** Yes No N/A**Qualified Welders:** Yes No N/A**Verified Joint Fit-up:** Yes No N/A**Approved Drawings:** Yes No N/A**Approved WPS:** Yes No N/A**Delayed / Cancelled:** Yes No N/A**Bridge No:** 34-0006**Component:** Travelers**Summary of Items Observed:**

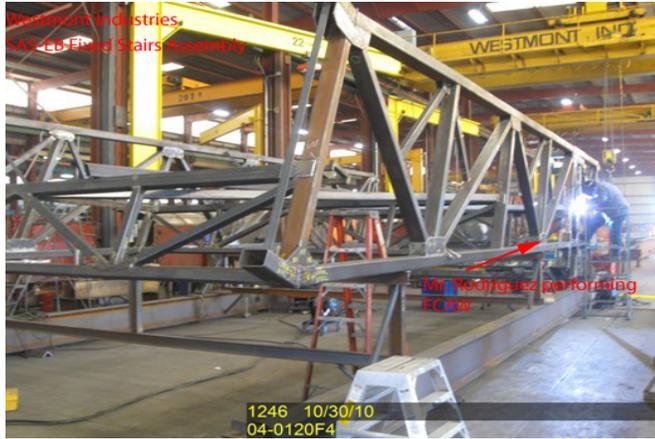
(WID # 3031), continuing to perform Flux Core Arc Welding (FCAW) activities on the previously fit Frame assemblies, identified as 10-A237, 11-B237, 3-A217, 4-A218, 5-A223 and 6-A224. The QA Inspector observed throughout the shift, that the FCAW was being performed in various positions, on the connector plate and Tube Steel (TS) material fillet and flare groove welds.

See attached picture below.
