Contract #: 04-0120F4Cty: SF/ALA Rte: 80 PM: 13.2/13.9File #: 1.28**WELDING INSPECTION REPORT****Resident Engineer:** Siegenthaler, Peter**Address:** 333 Burma Road**City:** Oakland, CA 94607**Report No:** WIR-017900**Date Inspected:** 04-Nov-2010**Project Name:** SAS Superstructure**OSM Arrival Time:** 1000**Prime Contractor:** American Bridge/Fluor Enterprises, a JV**OSM Departure Time:** 1830**Contractor:** American Bridge/Fluor Enterprises, a JV**Location:** Job Site

Caltrans Office of Structural Material (OSM) Quality Assurance Inspector (QAI) Joselito Lizardo was present at the Self Anchored Suspension (SAS) job site as requested to perform observations on the welding of components for the San Francisco Oakland Bay Bridge (SFOBB) Project.

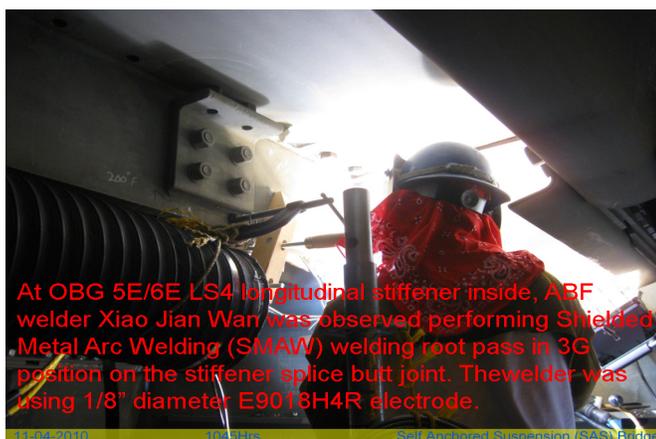
At OBG 5E/6E LS4 longitudinal stiffener inside, QA randomly observed ABF welder Xiao Jian Wan ID #9677 continuing to perform 3G (vertical) Shielded Metal Arc Welding (SMAW) complete joint penetration (CJP) back welding fill pass to cover pass on one side of the stiffener splice butt joint. The joint has a double V joint preparation that was being welded from one side using E9018H4R with 1/8" diameter electrode implementing Caltrans approved welding procedure specification (WPS) ABF-WPS-D1.5-1012-3. The joint being welded is a high strength plate material HPS 485W which has a thickness of 35mm was root welded using a ceramic backing. The splice joint was preheated and maintained to greater than 200 degrees Fahrenheit using Miller Proheat 35 Induction Heating System heater blanket located at the opposite side of the plate prior/during welding. During the shift, the welder has completed welding cover of the stiffener and held the preheat maintenance of 200 degrees F for three hours after welding. The QA Inspector noted the ABF QC John Pagliaro was on site monitoring the in process preheats and welding parameters. During the shift, QA noted ABF QC was closely monitoring the issuance of E9018H4R electrodes due to its limited exposure time allowed.

At OBG 5E/6E LS3 longitudinal stiffener inside, QA randomly observed ABF welder Hua Qiang Hwang ID #2930 continuing to perform 3G (vertical) Shielded Metal Arc Welding (SMAW) complete joint penetration (CJP) welding root pass then fill pass on one side of the stiffener splice butt joint. The joint has a double V joint preparation that was welded from one side using E9018H4R with 1/8" diameter electrode implementing Caltrans

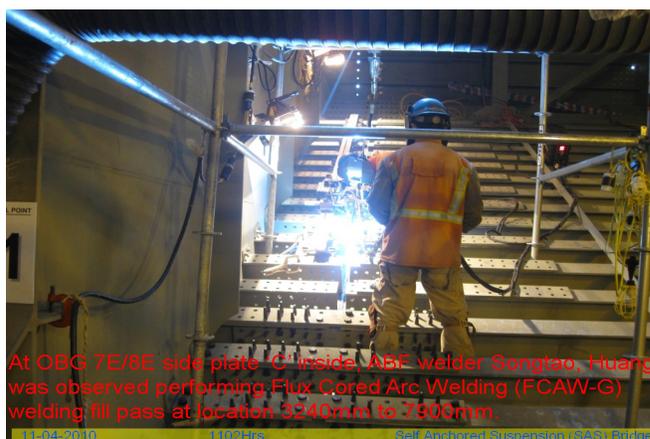
At OBG 7E/8E side plate 'C' (3240mm to 7900mm) inside, QA randomly observed ABF/JV qualified welder Sungtao, Huang ID # 3794 perform CJP groove (splice) welding root then fill pass on the splice butt joint. The welder was observed performing automatic welding in the 3G (vertical) position utilizing a dual shield Flux Cored Arc Welding (FCAW-G) with E71T-1M, 1/16" diameter wire electrode and implementing Caltrans approved Welding Procedure Specification (WPS) ABF-WPS-D15-3042B-1. The joint being welded had a single V-groove butt joint with backing bar. The splice joint was preheated and maintained to greater than 150 degrees Fahrenheit using Miller Proheat 35 Induction Heating System located at the opposite side of the plate prior/during welding. ABF Quality Control (QC) William Sherwood was noted monitoring the welding parameters of the welder. At the end of the shift, fill pass welding was still continuing and should remain tomorrow.
