**DEPARTMENT OF TRANSPORTATION**

Contract #: 04-0120F4Cty: SF/ALA Rte: 80 PM: 13.2/13.9File #: 1.28**WELDING INSPECTION REPORT****Resident Engineer:** Siegenthaler, Peter**Address:** 333 Burma Road**City:** Oakland, CA 94607**Report No:** WIR-017904**Date Inspected:** 08-Nov-2010**Project Name:** SAS Superstructure**OSM Arrival Time:** 1000**Prime Contractor:** American Bridge/Fluor Enterprises, a JV**OSM Departure Time:** 1830**Contractor:** American Bridge/Fluor Enterprises, a JV**Location:** Jobsite**CWI Name:** See below**CWI Present:** Yes No**Inspected CWI report:** Yes No N/A**Rod Oven in Use:** Yes No N/A**Electrode to specification:** Yes No N/A**Weld Procedures Followed:** Yes No N/A**Qualified Welders:** Yes No N/A**Verified Joint Fit-up:** Yes No N/A**Approved Drawings:** Yes No N/A**Approved WPS:** Yes No N/A**Delayed / Cancelled:** Yes No N/A**Bridge No:** 34-0006**Component:** SAS OBG**Summary of Items Observed:**

2). OBG Field Splice of Ventilation Access Insert Weld at 5E-PP29.5-E2-S – (SMAW)

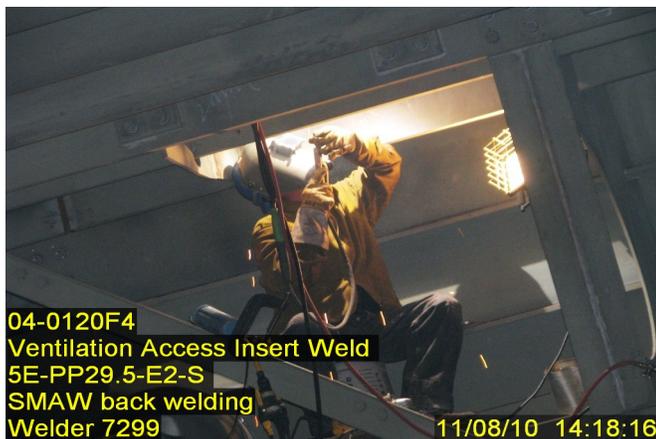
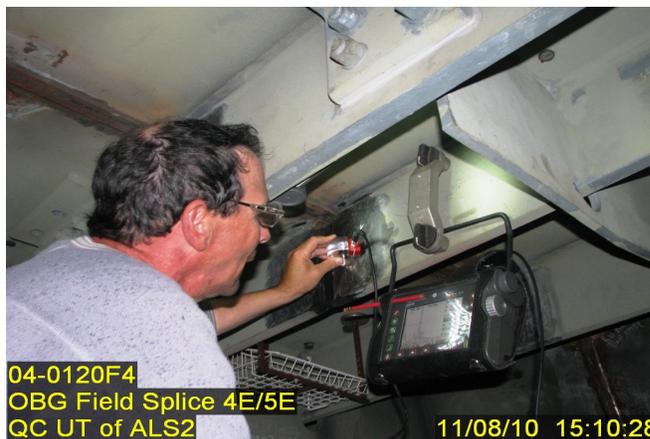
The QAI periodically observed back grinding and subsequent back welding of the Ventilation Access Insert at 5E-PP29.5-E2-S. The QAI periodically observed that AB/F approved welder Jin Pei Wang (ID 7299) performed welding per the Shielded Metal Arc Welding (SMAW) process in the 4G (overhead) position. See photo below. QC Inspector John Pagliero was periodically present to monitor the progress and verify that the welding parameters were within the limits established by the approved welding Procedure Specification (WPS) identified as ABF-WPS-D1.5-1010 rev 1. The QAI also observed QC John Pagliero performing Magnetic Particle Testing (MT) of the back grind area prior to back welding at this location. The QAI observed that the performance and evaluation of the MT appeared to comply with the MT procedure identified as SE-MT-CT-D1.5-101 Rev. 4. The QAI observed that back welding was in process at this location and the work at this location appeared to be in general compliance with contract documents.
