DEPARTMENT OF TRANSPORTATION

Quality Assurance and Source Inspection

Contract #: 04-0120F4Cty: SF/ALA Rte: 80 PM: 13.2/13.9File #: 99.28**WELDING INSPECTION REPORT****Resident Engineer:** Siegenthaler, Peter**Address:** 333 Burma Road**City:** Oakland, CA 94607**Report No:** WIR-017923**Date Inspected:** 10-Nov-2010**Project Name:** SAS Superstructure**OSM Arrival Time:** 700**Prime Contractor:** American Bridge/Fluor Enterprises, a JV**OSM Departure Time:** 1900**Contractor:** Zhenhua Port Machinery Company, Ltd (ZPMC) Chanxing Island **Location:** Shanghai, China**CWI Name:** Mr. Xu Tao**CWI Present:** Yes No**Inspected CWI report:** Yes No N/A**Rod Oven in Use:** Yes No N/A**Electrode to specification:** Yes No N/A**Weld Procedures Followed:** Yes No N/A**Qualified Welders:** Yes No N/A**Verified Joint Fit-up:** Yes No N/A**Approved Drawings:** Yes No N/A**Approved WPS:** Yes No N/A**Delayed / Cancelled:** Yes No N/A**Bridge No:** 34-0006**Component:** OBG Bike Path**Summary of Items Observed:**

WELDING INSPECTION REPORT

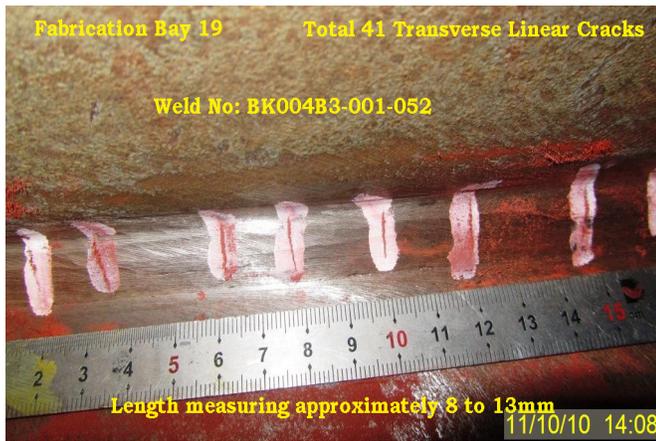
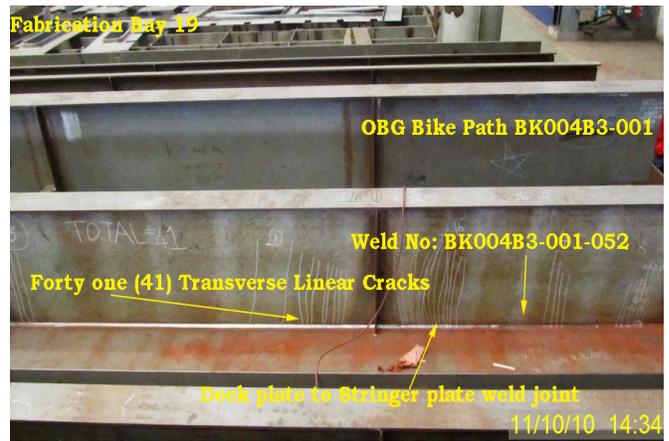
Description of Incident: During random Quality Assurance visual and work in progress of welds located on OBG Bike Path, ZPMC Quality Control Inspector (QC) discovered that forty one (41) Transverse Linear Cracks with each measuring approximately 8 to 13mm in length. The cracks were found on sole plate of bike path identified as BK004B3-001-052. The weld is fillet weld joint, joining the deck panel to stringer plate, this plate are identified as

non Seismic Performance Critical Member (non SPCM). The indications are clearly marked on the material near the weld. OBG Bike Path BK004B-001 is located at Bay#19. The Caltrans (CT) Quality Assurance Inspector (QA) requested to ZPMC QC, to prepare Critical weld repair report (CWR) and perform weld repair on above mention weld and after 48 hrs perform MT on same locations. See the attached picture.
