DEPARTMENT OF TRANSPORTATION

Quality Assurance and Source Inspection

Contract #: 04-0120F4Cty: SF/ALA Rte: 80 PM: 13.2/13.9File #: 1.28**WELDING INSPECTION REPORT****Resident Engineer:** Siegenthaler, Peter**Address:** 333 Burma Road**City:** Oakland, CA 94607**Report No:** WIR-017941**Date Inspected:** 09-Nov-2010**Project Name:** SAS Superstructure**OSM Arrival Time:** 1000**Prime Contractor:** American Bridge/Fluor Enterprises, a JV**OSM Departure Time:** 1830**Contractor:** American Bridge/Fluor Enterprises, a JV**Location:** Job Site

WELDING INSPECTION REPORT

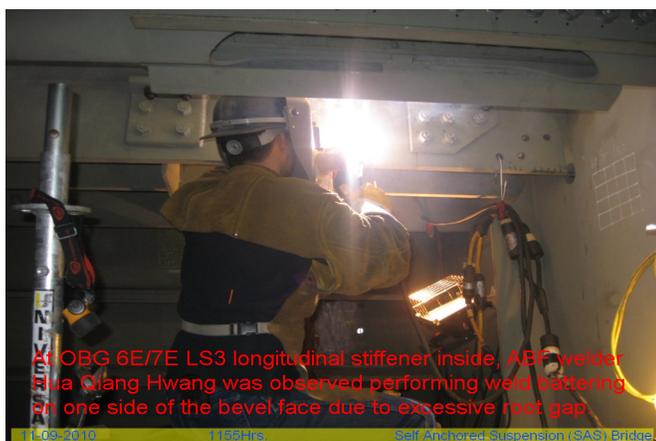
At OBG 6E/7E LS3 longitudinal stiffener inside, ABF welder Hua Qiang Hwang was observed performing weld baking on one side of the bevel face due to excessive root gap.

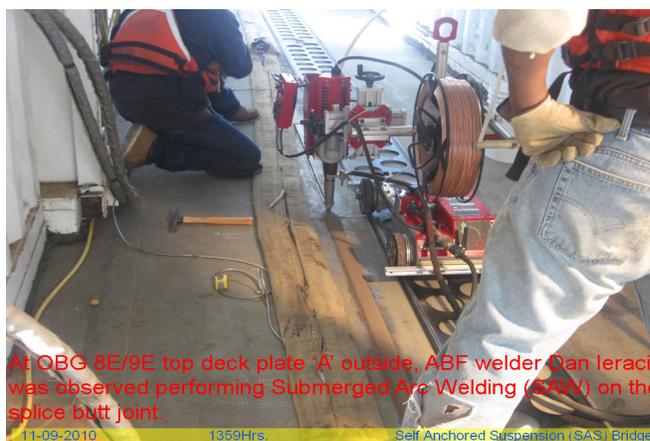
At OBG 8E/9E top deck plate 'A' outside, ABF welder Dan Ieraci was observed performing Submerged Arc Welding (SAW) on the splice butt joint.
