Quality Assurance and Source Inspection

Contract #: 04-0120F4Cty: SF/ALA Rte: 80 PM: 13.2/13.9File #: 1.28**WELDING INSPECTION REPORT****Resident Engineer:** Siegenthaler, Peter**Address:** 333 Burma Road**City:** Oakland, CA 94607**Report No:** WIR-017992**Date Inspected:** 25-Aug-2010**Project Name:** SAS Superstructure**OSM Arrival Time:** 1100**Prime Contractor:** American Bridge/Fluor Enterprises, a JV**OSM Departure Time:** 1330**Contractor:** American Bridge/Fluor Enterprises, a JV**Location:** Pier 7 - Jobsite**CWI Name:** Chuck Kanapicki**CWI Present:** Yes No**Inspected CWI report:** Yes No N/A**Rod Oven in Use:** Yes No N/A**Electrode to specification:** Yes No N/A**Weld Procedures Followed:** Yes No N/A**Qualified Welders:** Yes No N/A**Verified Joint Fit-up:** Yes No N/A**Approved Drawings:** Yes No N/A**Approved WPS:** Yes No N/A**Delayed / Cancelled:** Yes No N/A**Bridge No:** 34-0006**Component:** OBG Lift 8E**Summary of Items Observed:**

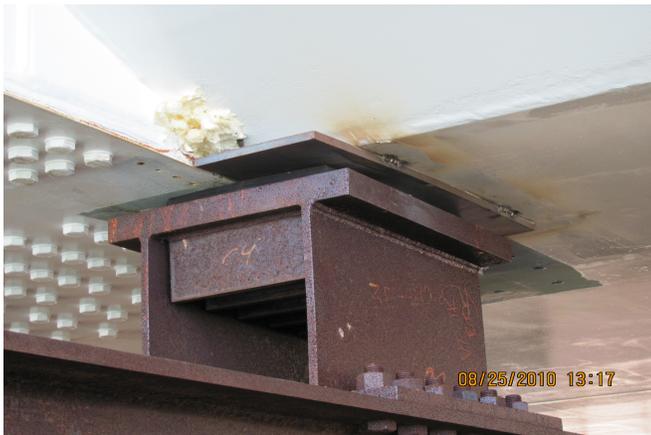
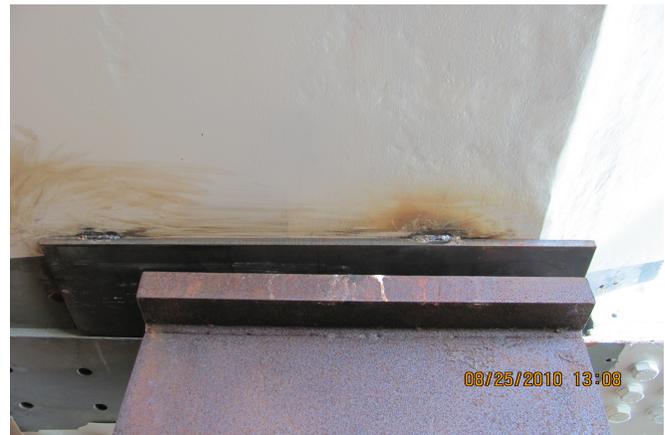
QA Mertz observed two (2) temporary shim plates welded to the bottom plate on one side of each of the two (2) crossbeam openings. These will require removal and repairs per ABF repair procedure in submittal 1361 Revision 3. (See photos below)

QA Mertz informed METS SMR, Mohammad Fatemi of the results of the visual inspections. QA Mertz also notified ABF-JV QCM, Chuck Kanapicki so the temporary welds could be addressed by ABF.
