Quality Assurance and Source Inspection

Contract #: 04-0120F4Cty: SF/ALA Rte: 80 PM: 13.2/13.9File #: 69.28**WELDING INSPECTION REPORT****Resident Engineer:** Siegenthaler, Peter**Address:** 333 Burma Road**City:** Oakland, CA 94607**Report No:** WIR-017996**Date Inspected:** 08-Nov-2010**Project Name:** SAS Superstructure**OSM Arrival Time:** 700**Prime Contractor:** American Bridge/Fluor Enterprises, a JV**OSM Departure Time:** 1900**Contractor:** Zhenhua Port Machinery Company, Ltd (ZPMC), Changxing Island **Location:** Shanghai, China**CWI Name:** Mr. Tian lei**CWI Present:** Yes No**Inspected CWI report:** Yes No N/A**Rod Oven in Use:** Yes No N/A**Electrode to specification:** Yes No N/A**Weld Procedures Followed:** Yes No N/A**Qualified Welders:** Yes No N/A**Verified Joint Fit-up:** Yes No N/A**Approved Drawings:** Yes No N/A**Approved WPS:** Yes No N/A**Delayed / Cancelled:** Yes No N/A**Bridge No:** 34-0006**Component:** Orthotropic Box Girder (OBG)**Summary of Items Observed:**

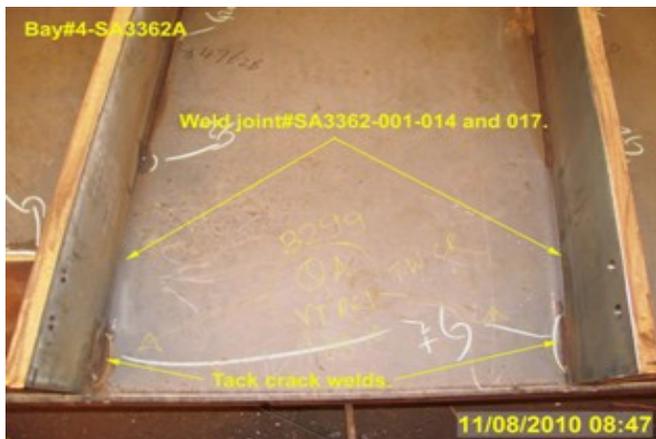
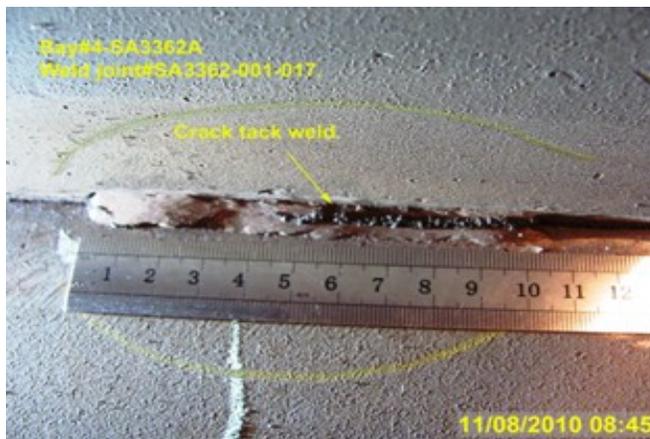
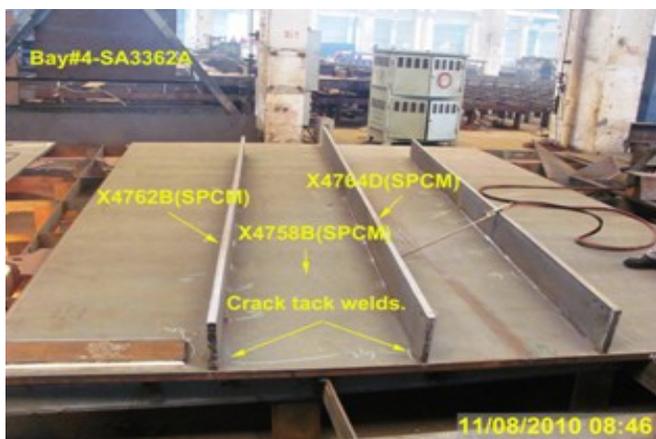
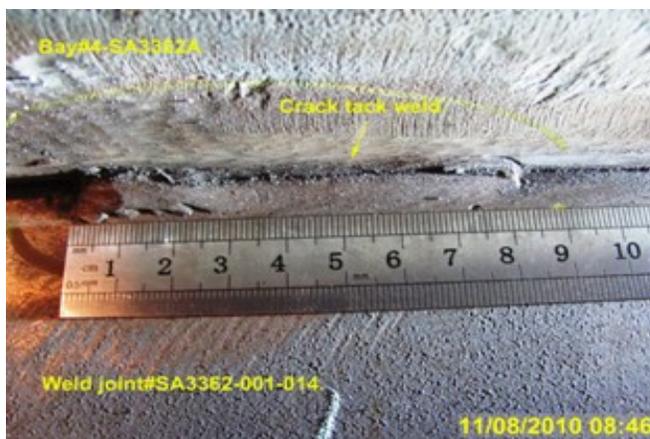
During random in process inspection of OBG member identified as SA3362A, this QA observed a cracked tack welds on weld joints are identified as SA3362-001-014 and 017. This QA marked the cracked tacks and informed ZPMC Quality Control (QC) indentified as Mr. Zhan yaxu of this issue. Mr. Zhan yaxu informed this QA that the cracked tacks would be corrected in a manner compliant with the contract documents. Refer the attached photos for reference.
