**DEPARTMENT OF TRANSPORTATION**

Quality Assurance and Source Inspection

Contract #: 04-0120F4Cty: SF/ALA Rte: 80 PM: 13.2/13.9File #: 69.28**WELDING INSPECTION REPORT****Resident Engineer:** Siegenthaler, Peter**Address:** 333 Burma Road**City:** Oakland, CA 94607**Report No:** WIR-018009**Date Inspected:** 22-Oct-2010**Project Name:** SAS Superstructure**OSM Arrival Time:** 700**Prime Contractor:** American Bridge/Fluor Enterprises, a JV**OSM Departure Time:** 1900**Contractor:** Zhenhua Port Machinery Company, Ltd (ZPMC), Changxing Island **Location:** Shanghai, China**CWI Name:** Mr. Chen xi**CWI Present:** Yes No**Inspected CWI report:** Yes No N/A**Rod Oven in Use:** Yes No N/A**Electrode to specification:** Yes No N/A**Weld Procedures Followed:** Yes No N/A**Qualified Welders:** Yes No N/A**Verified Joint Fit-up:** Yes No N/A**Approved Drawings:** Yes No N/A**Approved WPS:** Yes No N/A**Delayed / Cancelled:** Yes No N/A**Bridge No:** 34-0006**Component:** Orthotropic Box Girder (OBG)**Summary of Items Observed:**

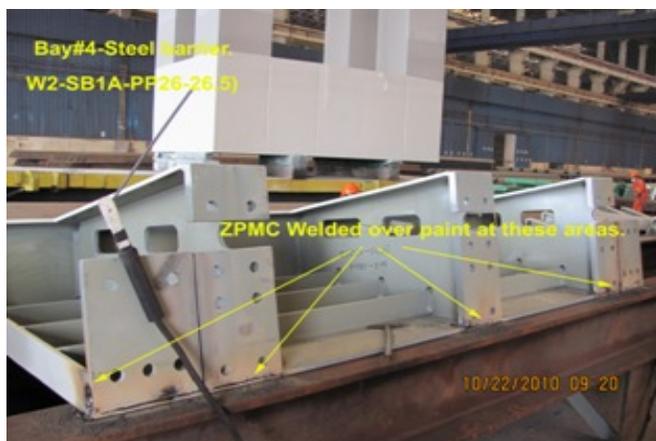
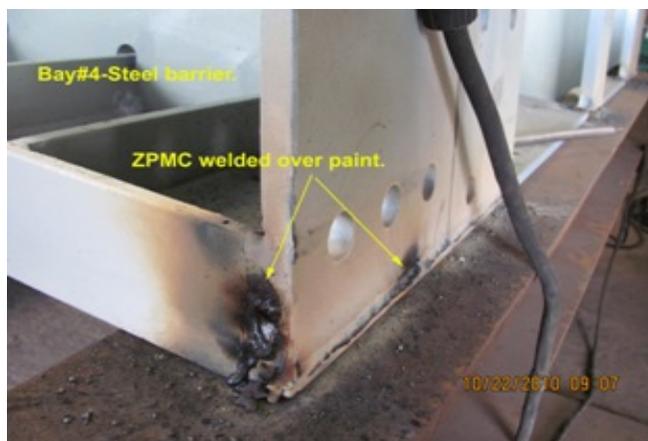
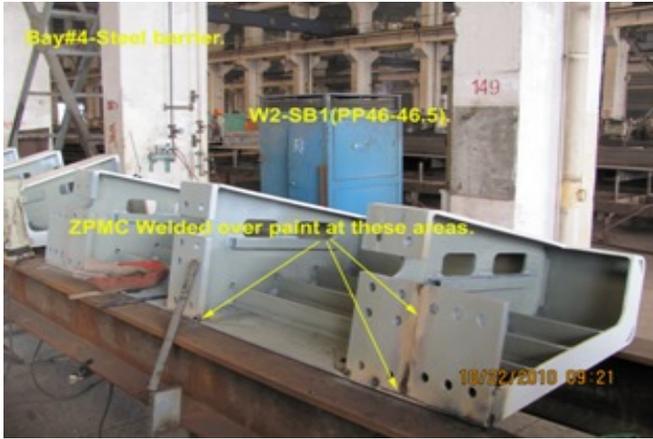
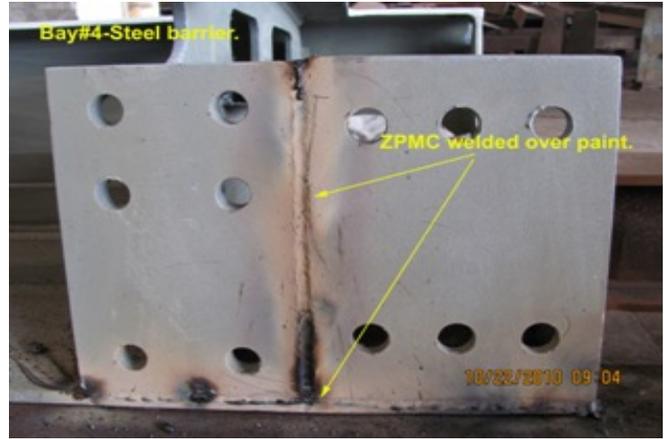
During the Caltrans QA Random in process inspection of the steel barriers, this QA observed ZPMC has performed seal welding without first removing the paint from the surfaces to be welded on steel barrier sections. The welds are joining the W2-P1 and 3 to the skins. The barriers are affected by this condition is identified as W2-SB1-PP46-465 and W2-SB1A-PP26-PP26.5. This QA informed American Bridge/Fluor (AB/F) QA Inspector identified as Mr. Wang wen bin and Liu lai qian of this issue. Mr. Wang wen bin and Liu lai qian informed this QA that paint will be removed prior to welding on all future barriers. This QA also informed to Caltrans Lead QA Inspector for the above issue. Additionally, Mr. Wang wen bin and Liu lai qian has instructed ZPMC workers and QC to Remove the paint prior to welding on all future barriers, as specified in the contract documents. Refer the attached photos for reference.
