Contract #: 04-0120F4Cty: SF/ALA Rte: 80 PM: 13.2/13.9File #: 69.28**WELDING INSPECTION REPORT****Resident Engineer:** Siegenthaler, Peter**Address:** 333 Burma Road**City:** Oakland, CA 94607**Report No:** WIR-018032**Date Inspected:** 23-Oct-2010**Project Name:** SAS Superstructure**OSM Arrival Time:** 700**Prime Contractor:** American Bridge/Fluor Enterprises, a JV**OSM Departure Time:** 1900**Contractor:** Zhenhua Port Machinery Company, Ltd (ZPMC), Changxing Island **Location:** Shanghai, China

WELDING INSPECTION REPORT

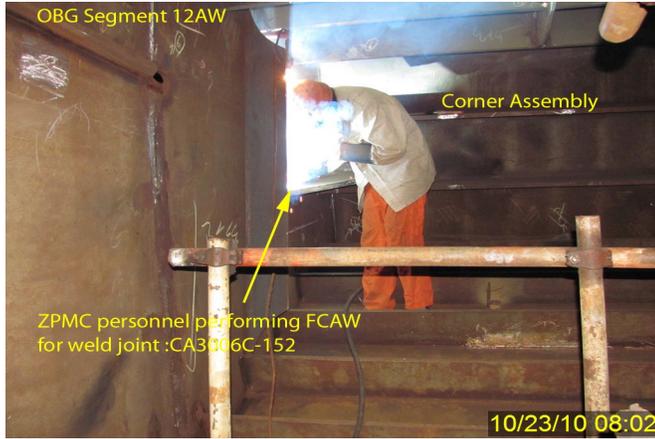
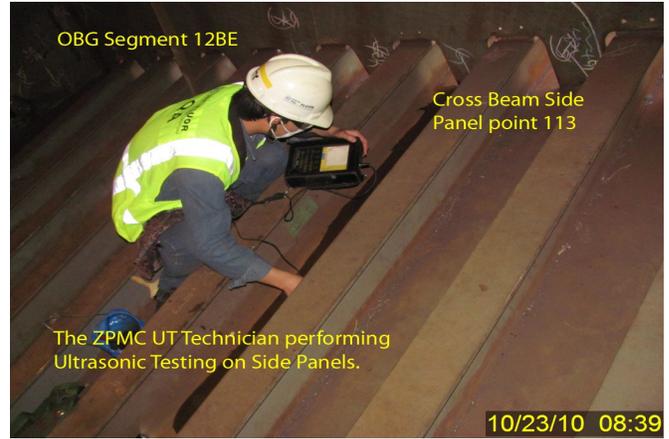
FCAW in the 2G position for the OBG Segment 12AW, The weld joint was designated as: CA3006C-152. The welder is identified as #048714. ZPMC QC is identified as Mr. Wang Wei Ming. The welding variables recorded by QC appear to comply with WPS-B-T-2232-TC-U4C-F. Please see the attached picture.
