**DEPARTMENT OF TRANSPORTATION**

Contract #: 04-0120F4Cty: SF/ALA Rte: 80 PM: 13.2/13.9File #: 69.28**WELDING INSPECTION REPORT****Resident Engineer:** Siegenthaler, Peter**Address:** 333 Burma Road**City:** Oakland, CA 94607**Report No:** WIR-018075**Date Inspected:** 15-Oct-2010**Project Name:** SAS Superstructure**OSM Arrival Time:** 700**Prime Contractor:** American Bridge/Fluor Enterprises, a JV**OSM Departure Time:** 1900**Contractor:** Zhenhua Port Machinery Company, Ltd (ZPMC), Changxing Island **Location:** Shanghai, China**CWI Name:** Xu Xian Ping**CWI Present:** Yes No**Inspected CWI report:** Yes No N/A**Rod Oven in Use:** Yes No N/A**Electrode to specification:** Yes No N/A**Weld Procedures Followed:** Yes No N/A**Qualified Welders:** Yes No N/A**Verified Joint Fit-up:** Yes No N/A**Approved Drawings:** Yes No N/A**Approved WPS:** Yes No N/A**Delayed / Cancelled:** Yes No N/A**Bridge No:** 34-0006**Component:** Orthotropic Box Girder (OBG)**Summary of Items Observed:**

# WELDING INSPECTION REPORT

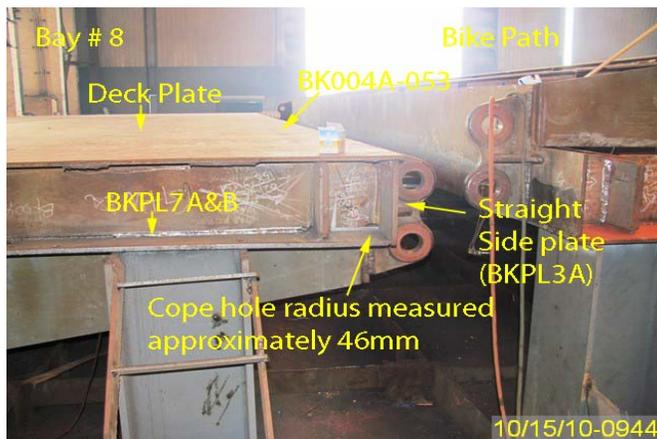
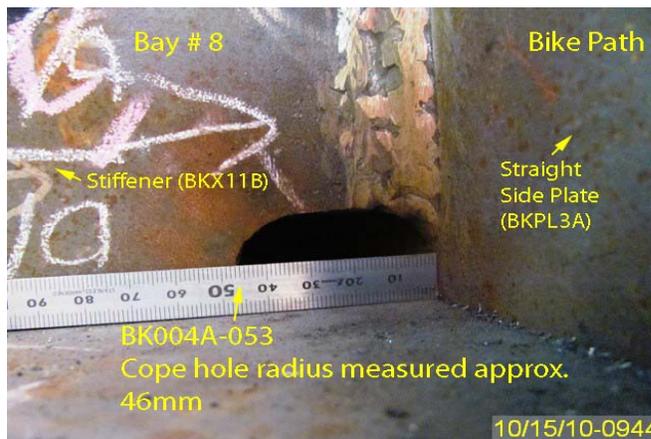
During the Caltrans Quality Assurance in-process observations of the fabrication of Bike Path, this Quality Assurance Inspector (QA) discovered the following issues. The over sized cope holes were observed in the Stiffener, BKX11B. According to the shop drawings, the Cope Hole radius was 25mm or 25mmx25mm snip corner. ZPMC personnel trimmed the corners up to approximately 46mmX25mm. The stiffener is connected to the side plate BKPL3A and the bearing plate BKPL7A/B. The affected Bike Paths are identified as BK004A-053, BK004A-054 & BK004A-055. This QA notified ZPMC QC identified as Mr. Feng ya jun of this issue and that an incident report would be generated. See attached pictures.
