**DEPARTMENT OF TRANSPORTATION**

Contract #: 04-0120F4Cty: SF/ALA Rte: 80 PM: 13.2/13.9File #: 69.28**WELDING INSPECTION REPORT****Resident Engineer:** Siegenthaler, Peter**Address:** 333 Burma Road**City:** Oakland, CA 94607**Report No:** WIR-018085**Date Inspected:** 13-Nov-2010**Project Name:** SAS Superstructure**OSM Arrival Time:** 700**Prime Contractor:** American Bridge/Fluor Enterprises, a JV**OSM Departure Time:** 1900**Contractor:** Zhenhua Port Machinery Company, Ltd (ZPMC), Changxing Island **Location:** Shanghai, China**CWI Name:** Zhu Zhong Hai.**CWI Present:** Yes No**Inspected CWI report:** Yes No N/A**Rod Oven in Use:** Yes No N/A**Electrode to specification:** Yes No N/A**Weld Procedures Followed:** Yes No N/A**Qualified Welders:** Yes No N/A**Verified Joint Fit-up:** Yes No N/A**Approved Drawings:** Yes No N/A**Approved WPS:** Yes No N/A**Delayed / Cancelled:** Yes No N/A**Bridge No:** 34-0006**Component:** OBG components.**Summary of Items Observed:**

## WELDING INSPECTION REPORT

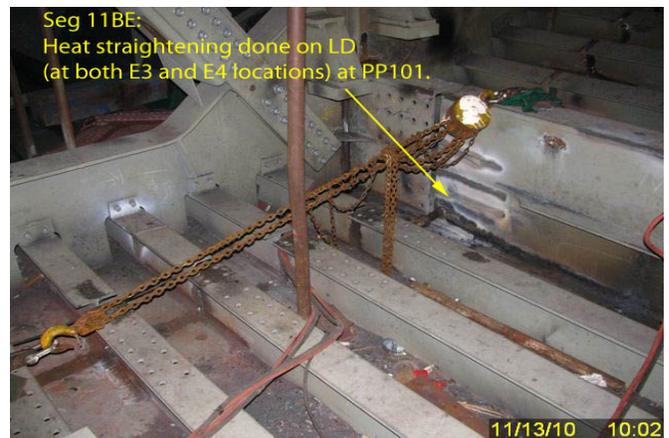
This QA Inspector observed ZPMC personnel doing heat straightening on LD (at both E3 and E4 location) of Seg 11BE at PP101. Heat straightening was done as per HSR report: 9824. ZPMC QC was identified as Wang Li Yang. See attached photo for further details. See attached photos for further details.
