Contract #: 04-0120F4Cty: SF/ALA Rte: 80 PM: 13.2/13.9File #: 69.28**WELDING INSPECTION REPORT****Resident Engineer:** Siegenthaler, Peter**Address:** 333 Burma Road**City:** Oakland, CA 94607**Report No:** WIR-018157**Date Inspected:** 16-Nov-2010**Project Name:** SAS Superstructure**OSM Arrival Time:** 700**Prime Contractor:** American Bridge/Fluor Enterprises, a JV**OSM Departure Time:** 1900**Contractor:** Zhenhua Port Machinery Company, Ltd (ZPMC), Changxing Island **Location:** Shanghai, China**CWI Name:** Mr. Li zhi jiang**CWI Present:** Yes No**Inspected CWI report:** Yes No N/A**Rod Oven in Use:** Yes No N/A**Electrode to specification:** Yes No N/A**Weld Procedures Followed:** Yes No N/A**Qualified Welders:** Yes No N/A**Verified Joint Fit-up:** Yes No N/A**Approved Drawings:** Yes No N/A**Approved WPS:** Yes No N/A**Delayed / Cancelled:** Yes No N/A**Bridge No:** 34-0006**Component:** Orthotropic Box Girder (OBG)**Summary of Items Observed:**

This CALTRANS OSM Quality Assurance Inspector (QA) Surendra Prabhu was present during the times noted above for observations relative to the fabrication of the Self Anchored Suspension (SAS) Superstructure being performed by Zhenhu

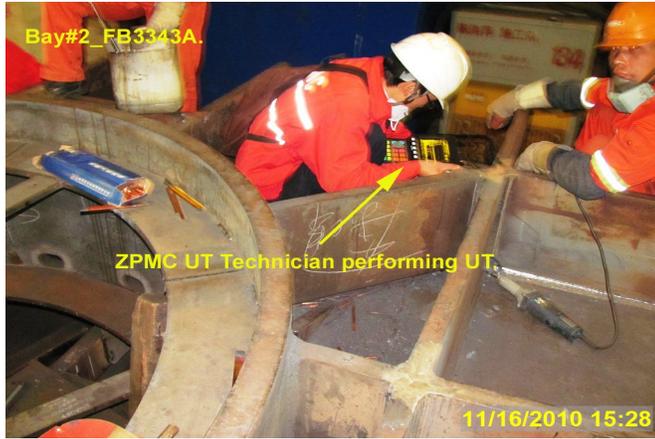
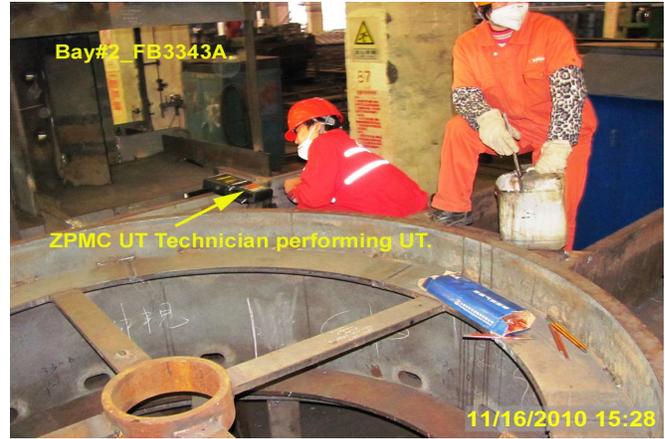
ZPMC UT Technicians performing Ultrasonic Testing for the welds located on Floor beam identified as FB3343A. Refer the attached photos for reference.
