**DEPARTMENT OF TRANSPORTATION**

Contract #: 04-0120F4Cty: SF/ALA Rte: 80 PM: 13.2/13.9File #: 82.28**WELDING INSPECTION REPORT****Resident Engineer:** Siegenthaler, Peter**Address:** 333 Burma Road**City:** Oakland, CA 94607**Report No:** WIR-018183**Date Inspected:** 12-Nov-2010**Project Name:** SAS Superstructure**OSM Arrival Time:** 700**Prime Contractor:** American Bridge/Fluor Enterprises, a JV**OSM Departure Time:** 1530**Contractor:** Westmont Industries**Location:** Santa Fe Springs, CA.**CWI Name:** Ruben Dominguez**CWI Present:** Yes No**Inspected CWI report:** Yes No N/A**Rod Oven in Use:** Yes No N/A**Electrode to specification:** Yes No N/A**Weld Procedures Followed:** Yes No N/A**Qualified Welders:** Yes No N/A**Verified Joint Fit-up:** Yes No N/A**Approved Drawings:** Yes No N/A**Approved WPS:** Yes No N/A**Delayed / Cancelled:** Yes No N/A**Bridge No:** 34-0006**Component:** Travelers**Summary of Items Observed:**

**Traveler Test Rack**

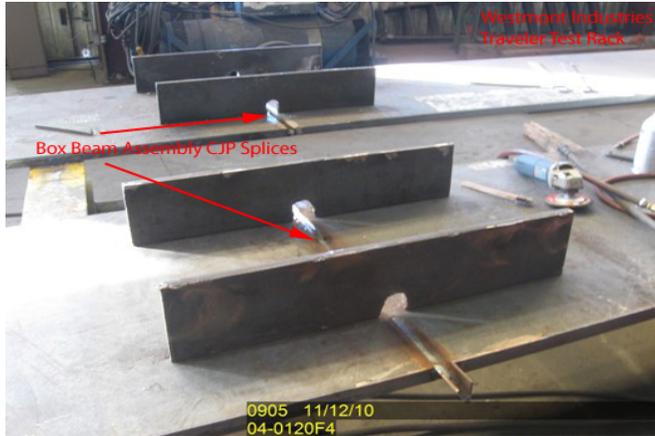
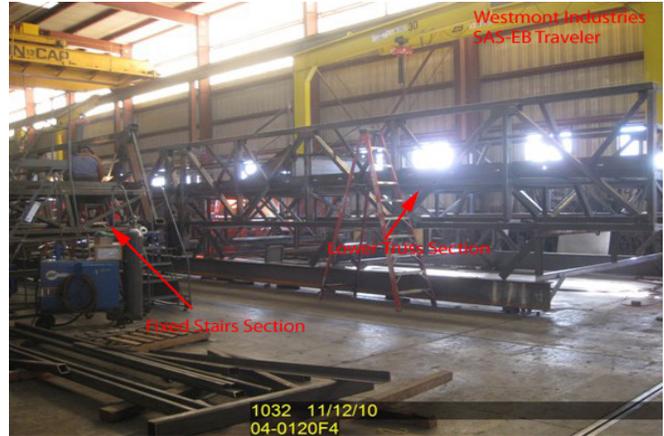
On this date, The QA Inspector observed production welders Mr. Jim Muetzel (WID # 3133) and Mr. Larry Swanson continuing to perform Gas Metal Arc welding (GMAW) and fitting activities on plate material, for the Traveler Test Rack. The QA Inspector observed that the activities were being performed on the top and bottom flange plate material Complete Joint Penetration (CJP) splices, for the Box Beam Assembly 1-A1 and 1-A2.

See attached picture below.
