DEPARTMENT OF TRANSPORTATION

Contract #: 04-0120F4Cty: SF/ALA Rte: 80 PM: 13.2/13.9File #: 69.28**WELDING INSPECTION REPORT****Resident Engineer:** Siegenthaler, Peter**Address:** 333 Burma Road**City:** Oakland, CA 94607**Report No:** WIR-018213**Date Inspected:** 19-Nov-2010**Project Name:** SAS Superstructure**OSM Arrival Time:** 700**Prime Contractor:** American Bridge/Fluor Enterprises, a JV**OSM Departure Time:** 1900**Contractor:** Zhenhua Port Machinery Company, Ltd (ZPMC), Changxing Island **Location:** Shanghai, China**CWI Name:** An Qing Xiang**CWI Present:** Yes No**Inspected CWI report:** Yes No N/A**Rod Oven in Use:** Yes No N/A**Electrode to specification:** Yes No N/A**Weld Procedures Followed:** Yes No N/A**Qualified Welders:** Yes No N/A**Verified Joint Fit-up:** Yes No N/A**Approved Drawings:** Yes No N/A**Approved WPS:** Yes No N/A**Delayed / Cancelled:** Yes No N/A**Bridge No:** 34-0006**Component:** Orthotropic Box Girder (OBG)**Summary of Items Observed:**

OBG TRIAL ASSEMBLY YARD

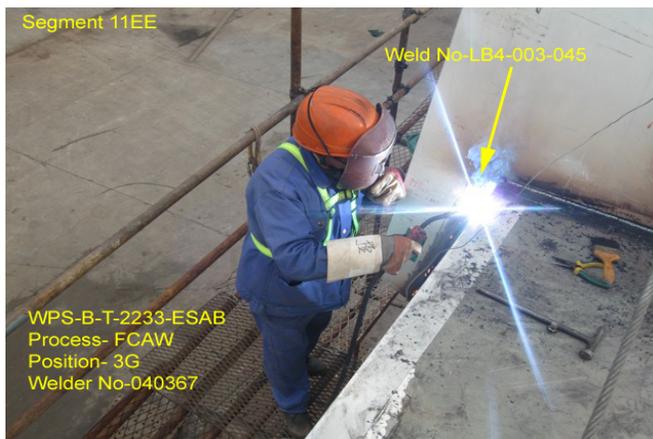
WELDING:**Segment 11EE**

This QA Inspector observed ZPMC qualified welding personnel identified as 040367 perform Flux Core Arc Welding (FCAW), weld joint identified as LB4-003-045; located On Orthotropic Box Girder (OBG) Deck Plate to Edge Plate Transverse PJP Weld. ZPMC QC is identified as Mr. An Qing Xiang. The welding parameters measured using QC's calibrated instrument appeared to be in general compliance with applicable WPS-B-T-2233-ESAB. See attached photo for further details.

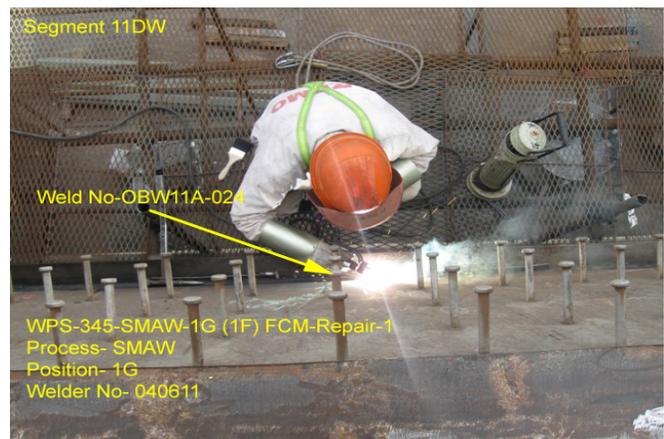
Segment 11DW

This QA Inspector observed ZPMC qualified welding personnel identified as 040611 perform Shielded Metal Arc Welding (SMAW), weld joint identified as OBW11A-024; located On Orthotropic Box Girder (OBG) Deck Plate to Connection Plate CJP Weld; The Welding Repair Report (WRR) was B-WR17275. ZPMC Quality Control (QC) is identified as Mr. Zhou Peng. The welding variables recorded by QC appeared to comply with applicable WPS-345-SMAW 1G (1F) FCM-Repair-1. See attached photo for further details.
