Quality Assurance and Source Inspection

Contract #: 04-0120F4Cty: SF/ALA Rte: 80 PM: 13.2/13.9File #: 1.28**WELDING INSPECTION REPORT****Resident Engineer:** Siegenthaler, Peter**Address:** 333 Burma Road**City:** Oakland, CA 94607**Report No:** WIR-018247**Date Inspected:** 19-Nov-2010**Project Name:** SAS Superstructure**OSM Arrival Time:** 900**Prime Contractor:** American Bridge/Fluor Enterprises, a JV**OSM Departure Time:** 1730**Contractor:** American Bridge/Fluor Enterprises, a JV**Location:** Job Site

WELDING INSPECTION REPORT

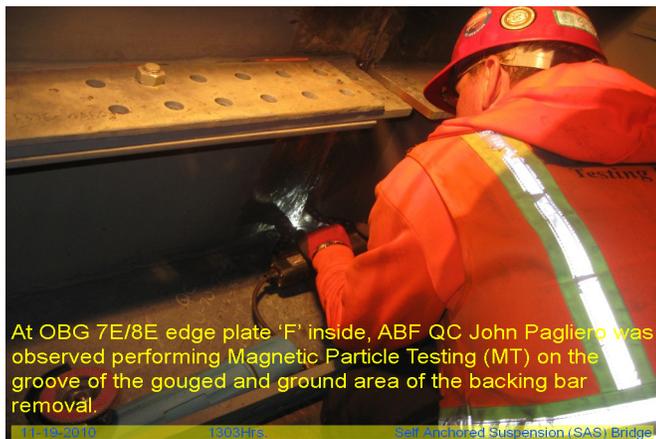
11-19-2019 12:04Hrs Self Anchored Suspension (SAS) Bridge

At OBG 7E/8E edge plate 'F' inside, ABF QC John Pagliero was observed performing Magnetic Particle Testing (MT) on the groove of the gouged and ground area of the backing bar removal.

At OBG 7E/8E edge plate 'F' inside, QA noted ABF welder Jorge Lopez back gouging the splice butt joint. The welder was using carbon air arc gouging and after its completion the welder was noted grinding the groove of the

gouged area of the joint. The smooth grinding of the gouged area was also completed and ABF QC John Pagliero was observed performing the Magnetic Particle Testing (MT) of the gouged and ground area of the joint. After the completion and acceptance of MT, the welder performed SMAW back welding fill pass on the splice joint. The welder was observed welding in the 3G (vertical) position utilizing 1/8" diameter E7018H4R electrode implementing welding procedure ABF-WPS-D15-1110A Revision 1. ABF Quality Control (QC) Bonifacio Daquinag was noted monitoring the welding parameters of the welder. At the end of the shift, fill pass welding was still continuing and should remain Monday.

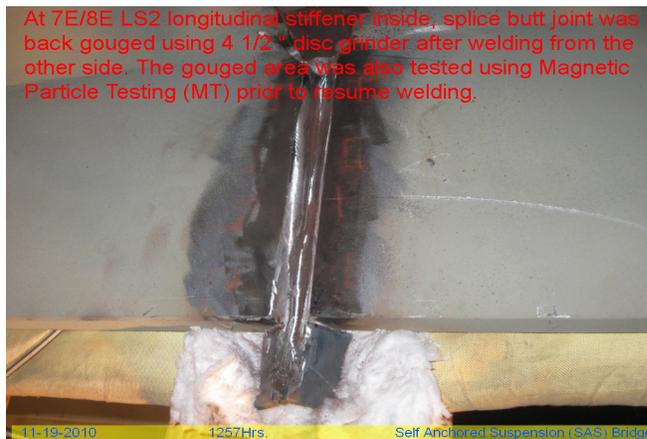
11-19-2019 12:57Hrs Self Anchored Suspension (SAS) Bridge

At 7E/8E LS2 longitudinal stiffener inside, splice butt joint was back gouged using 4 1/2" disc grinder after welding from the other side. The gouged area was also tested using Magnetic Particle Testing (MT) prior to resume welding.

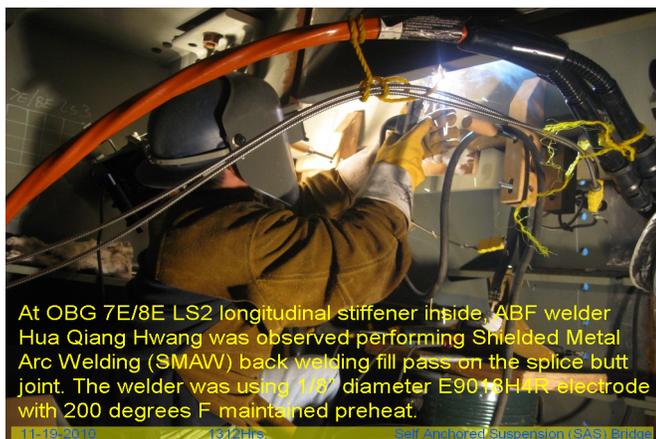
11-19-2019 12:21Hrs Self Anchored Suspension (SAS) Bridge

At OBG 7E/8E LS2 longitudinal stiffener inside, ABF welder Hua Qiang Hwang was observed performing Shielded Metal Arc Welding (SMAW) back welding fill pass on the splice butt joint. The welder was using 1/8" diameter E9018H4R electrode with 200 degrees F maintained preheat.

At OBG 7E/8E LS2 longitudinal stiffener inside, QA randomly observed ABF welder Hua Qiang Hwang ID #2930 perform 3G (vertical) Shielded Metal Arc Welding (SMAW) complete joint penetration (CJP) welding root pass cover pass on one side of the stiffener splice butt joint. The joint has a double V joint preparation that is being welded from one side using E9018H4R with 1/8" diameter electrode implementing Caltrans approved welding procedure specification (WPS) ABF-WPS-D1.5-1012-3. The joint being welded is a high strength plate material HPS 485W which has a thickness of 30mm was root welded using a ceramic backing. The splice joint was preheated and maintained to greater than 200 degrees Fahrenheit using Miller Proheat 35 Induction Heating System heater blanket located at the opposite side of the plate prior/during welding. During the shift, cover welding at one side was completed and the welder has moved to the other side. The welder back gouged and ground smooths the other side and after its completion, ABF QC John Pagliero has performed the Magnetic Particle Testing. The welder continued back welding fill pass on the other side. At the end of the shift, fill pass welding of the stiffener was still continuing and should continue on Monday. The QA Inspector noted the ABF QC John Pagliero was on site monitoring the in process preheat and welding parameters. During the shift, QA noted ABF QC was closely monitoring the issuance of E9018H4R electrodes due to its limited exposure time allowed.

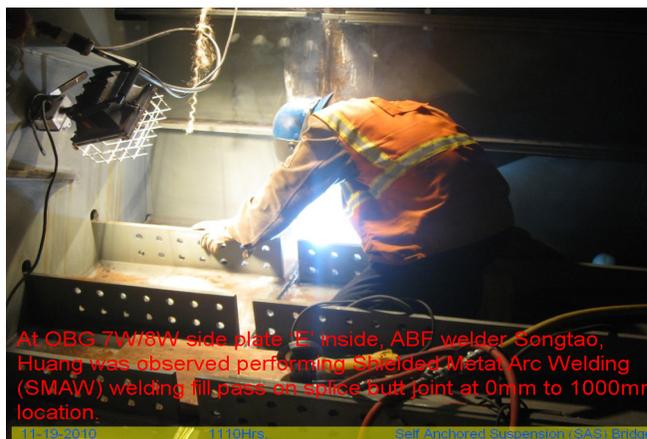
11-19-2019 11:10Hrs Self Anchored Suspension (SAS) Bridge

At OBG 7W/8W side plate 'E' inside, ABF welder Songtao, Huang was observed performing Shielded Metal Arc Welding (SMAW) welding fill pass on splice butt joint at 0mm to 1000mm location.

At OBG 7W/8W side plate 'E' inside, QA randomly observed ABF/JV qualified welder Sungtao, Huang ID # 3794 has completed the weld cover at location 1000mm to 3640mm. After its completion, the welder has moved to new location 0mm to 1000mm and performed root pass and fill pass welding using SMAW. The joint being welded with SMAW has a single V-groove butt joint with backing bar and limited access for the Bug-o track mounted FCAW-G nozzle holder. ABF Quality Control (QC) William Sherwood was noted monitoring the welding parameters of the welder. At the end of the shift, fill pass welding was still continuing and should remain Monday.
