Quality Assurance and Source Inspection

Contract #: 04-0120F4Cty: SF/ALA Rte: 80 PM: 13.2/13.9File #: 82.28**WELDING INSPECTION REPORT****Resident Engineer:** Siegenthaler, Peter**Address:** 333 Burma Road**City:** Oakland, CA 94607**Report No:** WIR-018251**Date Inspected:** 18-Nov-2010**Project Name:** SAS Superstructure**OSM Arrival Time:** 700**Prime Contractor:** American Bridge/Fluor Enterprises, a JV**OSM Departure Time:** 1530**Contractor:** Westmont Industries**Location:** Santa Fe Springs, CA.**CWI Name:** Ruben Dominguez**CWI Present:** Yes No**Inspected CWI report:** Yes No N/A**Rod Oven in Use:** Yes No N/A**Electrode to specification:** Yes No N/A**Weld Procedures Followed:** Yes No N/A**Qualified Welders:** Yes No N/A**Verified Joint Fit-up:** Yes No N/A**Approved Drawings:** Yes No N/A**Approved WPS:** Yes No N/A**Delayed / Cancelled:** Yes No N/A**Bridge No:** 34-0006**Component:** Travelers**Summary of Items Observed:**

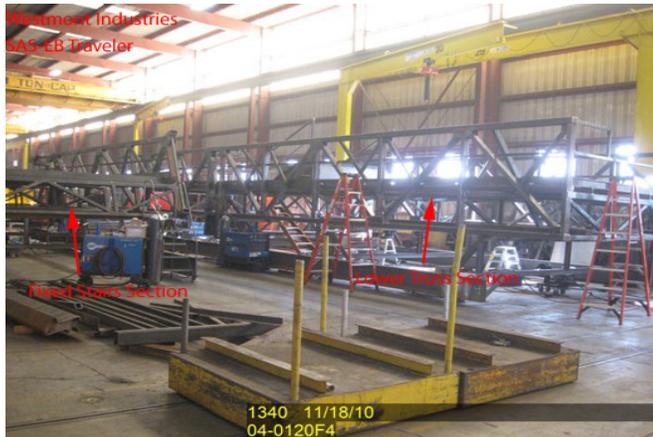
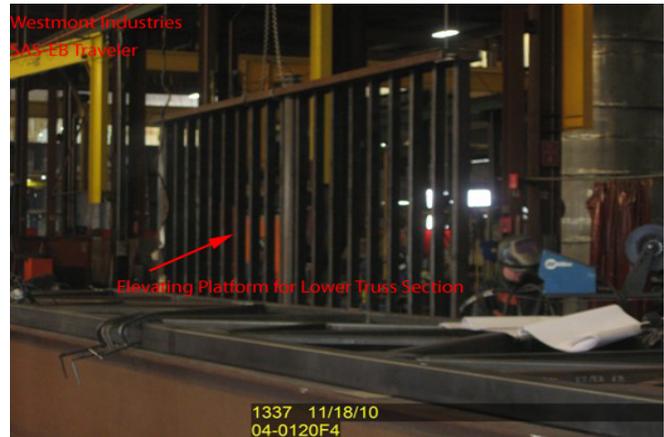
The QA Inspector observed WMI production personnel Mr. Raymundo Anaya (WID # 3196) and Mr. Cesar Canales performing fitting and tacking activities on the Elevating Platform, for the Lower Truss Section. The QA Inspector observed that the fitting and tacking activities were being performed on the Stair Risers, piece marks identified as C270F, to Stair Support, piece mark identified as B270F. The QA Inspector observed that the layout on the Stair Support material had been previously completed and the Stair Riser material was being fit-up and the Flux Core Arc Welding (FCAW) process was being utilized by Mr. Lopez, to perform the tack welding of the Stair Riser to Stair Support material. Later, the QA Inspector was informed by WMI production personnel Mr. Jose Rodriguez that the overhead bay crane had been previously utilized to lift and place the Elevating Platform into place and Mr. Rodriguez explained that the platform appeared to fit. Mr. Rodriguez further explained that after performing this preliminary fit test, that the platform was then placed back in the fabrication area, to continue the FCAW.

See attached pictures below.

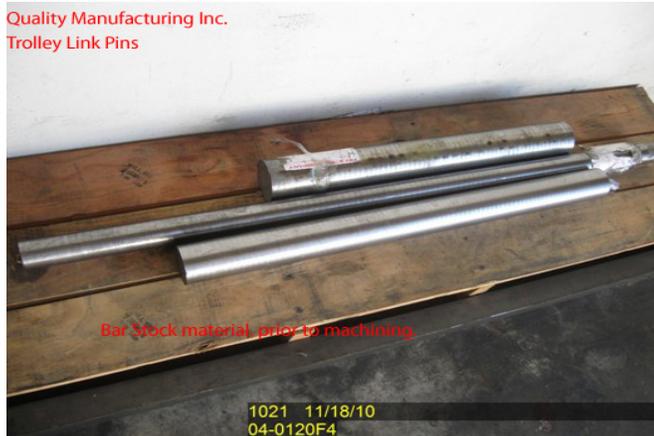
At approximately 0900, the QA Inspector arrived at QMI and met with a QMI representative. QMI explained that the material which has been received by Fry Steel Company and will be machined, per WMI instructions. QMI then showed the QA Inspector what appeared to be three lengths of bar stock material, which were placed on a wooden pallet, on the shop floor. The QA Inspector was then provided the Mill Test Reports (MTR's) and a Certificate of Compliance (COC), attached to the MTR's. The QA Inspector then requested a copy of the shop drawing, which was provided to QMI from Westmont Industries (WMI). After reviewing the shop drawing, the QA Inspector observed that the bar stock material will be utilized for the Trolley Link Pins identified as "P1" 21-A718, "P2" 22-B718 and "P3" 23-C718. After further review of the drawings, the QA Inspector observed that the manufacturing notes on the drawing explain that the material is designated as round bar heat treated ASTM A322, Grade 4140, hot dip galvanized. Additionally, the QA Inspector noted that the drawing explains that the diameters shown, include the thickness of the galvanizing. QMI then explained to the QA Inspector that after the cutting and machining is complete, that the material will then be sent out for heat treating and the hot dip galvanizing process. The QA Inspector observed that the above mentioned material appears to be in compliance with the contract requirements and is listed as follows:

- 1 each 2" round x 49" long-A322 Gr. 4140-Ht. # 8095313 Bar Stock
- 1 each 2.75" round x 33" long-A322 Gr. 4140-Ht. # 8095313 Bar Stock
- 1 each 3.125" round x 25" long-A322 Gr. 4140-Ht. # 8092889 Bar Stock

See attached picture below.
