**DEPARTMENT OF TRANSPORTATION**

Contract #: 04-0120F4Cty: SF/ALA Rte: 80 PM: 13.2/13.9File #: 69.28**WELDING INSPECTION REPORT****Resident Engineer:** Siegenthaler, Peter**Address:** 333 Burma Road**City:** Oakland, CA 94607**Report No:** WIR-018339**Date Inspected:** 14-Nov-2010**Project Name:** SAS Superstructure**OSM Arrival Time:** 700**Prime Contractor:** American Bridge/Fluor Enterprises, a JV**OSM Departure Time:** 1900**Contractor:** Zhenhua Port Machinery Company, Ltd (ZPMC), Changxing Island **Location:** Shanghai, China**CWI Name:** Xu Le Feng**CWI Present:** Yes No**Inspected CWI report:** Yes No N/A**Rod Oven in Use:** Yes No N/A**Electrode to specification:** Yes No N/A**Weld Procedures Followed:** Yes No N/A**Qualified Welders:** Yes No N/A**Verified Joint Fit-up:** Yes No N/A**Approved Drawings:** Yes No N/A**Approved WPS:** Yes No N/A**Delayed / Cancelled:** Yes No N/A**Bridge No:** 34-0006**Component:** TOWER & OBG Components**Summary of Items Observed:**

ORTHOTROPIC BOX GIRDER (OBG) AT BAY#10

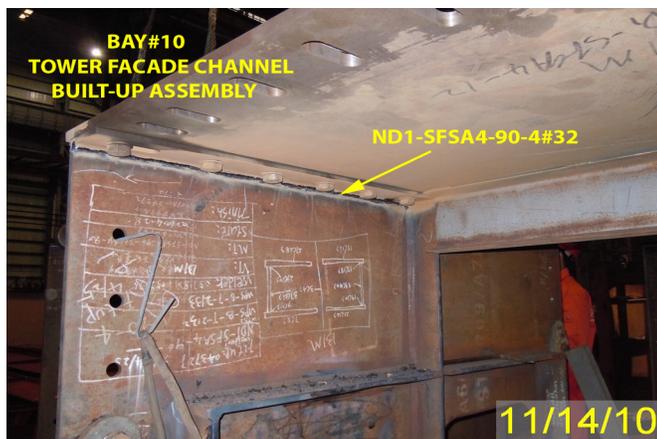
Weld joint # 032 located on Façade Channel built-up assembly, ND1-SFSA4-90-4. Welder is identified as 050038.

ZPMC Quality Control (QC) Inspector is identified as Jiang Xiao Bo. The welding variables recorded by QC appeared to comply with the WPS – B – P – 2114. (See attached photo)

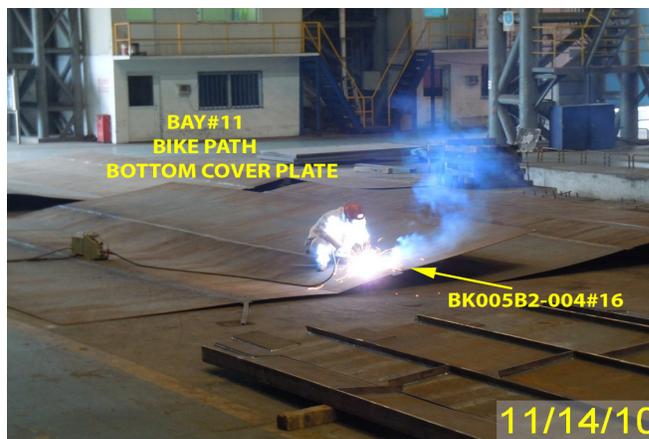
Weld joint # 016 located on Bike Path, BK005B2 – 004. Welder is identified as 040723. ZPMC Quality Control (QC) Inspector is identified as Yu Dong Ping. The welding variables recorded by QC appeared to comply with the WPS – B – T – 2231 – B – L1b – F – 1. (See attached photo)
