**DEPARTMENT OF TRANSPORTATION**

Contract #: 04-0120F4Cty: SF/ALA Rte: 80 PM: 13.2/13.9File #: 69.28**WELDING INSPECTION REPORT****Resident Engineer:** Siegenthaler, Peter**Address:** 333 Burma Road**City:** Oakland, CA 94607**Report No:** WIR-018425**Date Inspected:** 30-Nov-2010**Project Name:** SAS Superstructure**OSM Arrival Time:** 700**Prime Contractor:** American Bridge/Fluor Enterprises, a JV**OSM Departure Time:** 1900**Contractor:** Zhenhua Port Machinery Company, Ltd (ZPMC), Changxing Island **Location:** Shanghai, China**CWI Name:** Li Yang**CWI Present:** Yes No**Inspected CWI report:** Yes No N/A**Rod Oven in Use:** Yes No N/A**Electrode to specification:** Yes No N/A**Weld Procedures Followed:** Yes No N/A**Qualified Welders:** Yes No N/A**Verified Joint Fit-up:** Yes No N/A**Approved Drawings:** Yes No N/A**Approved WPS:** Yes No N/A**Delayed / Cancelled:** Yes No N/A**Bridge No:** 34-0006**Component:** OBG Segment**Summary of Items Observed:**

**OBG # TRIAL ASSEMBLY YARD (11EE)**

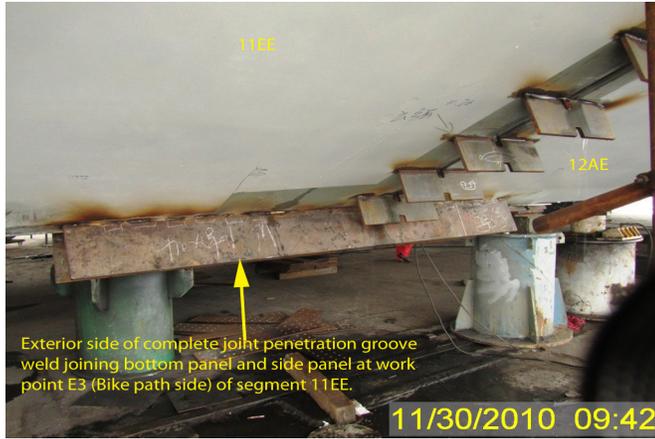
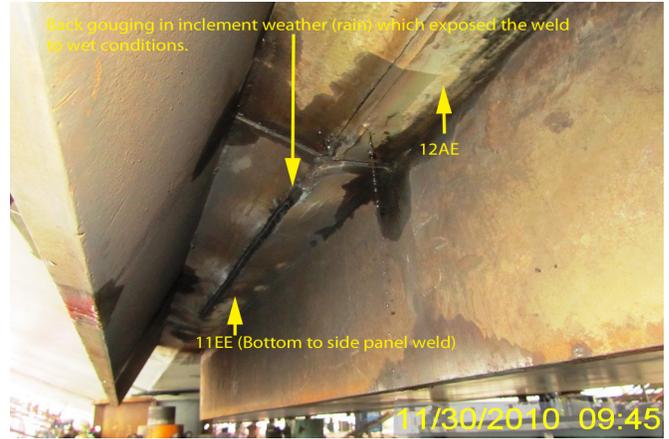
During random in process visual inspection of OBG Segment 11EE, this Caltrans Quality Assurance (QA) Inspector observed ZPMC personnel performing back gouging in inclement weather (rain) which exposed the weld to wet conditions.

The location was at the exterior side of complete joint penetration groove weld joining bottom panel and side panel at work point E3 (Bike path side) of segment 11EE.

The weld joint identified as SEG074A-012.

This weld is located between Panel Point (PP) 108 and PP 109.

An incident report was generated for the above issue identified in 11EE. See TL-6025 generated on this date for detailed information.
