Contract #: 04-0120F4Cty: SF/ALA Rte: 80 PM: 13.2/13.9File #: 1.28**WELDING INSPECTION REPORT****Resident Engineer:** Siegenthaler, Peter**Address:** 333 Burma Road**City:** Oakland, CA 94607**Report No:** WIR-018478**Date Inspected:** 02-Dec-2010**Project Name:** SAS Superstructure**OSM Arrival Time:** 1000**Prime Contractor:** American Bridge/Fluor Enterprises, a JV**OSM Departure Time:** 1830**Contractor:** American Bridge/Fluor Enterprises, a JV**Location:** Jobsite**CWI Name:** See below**CWI Present:** Yes No**Inspected CWI report:** Yes No N/A**Rod Oven in Use:** Yes No N/A**Electrode to specification:** Yes No N/A**Weld Procedures Followed:** Yes No N/A**Qualified Welders:** Yes No N/A**Verified Joint Fit-up:** Yes No N/A**Approved Drawings:** Yes No N/A**Approved WPS:** Yes No N/A**Delayed / Cancelled:** Yes No N/A**Bridge No:** 34-0006**Component:** SAS OBG**Summary of Items Observed:**

- 1). OBG Field Splice 7E/8E Weld ID: C1, Face B – (FCAW-G)
- 2). OBG Field Splice 6E/7E A Longitudinal Stiffener (LS) 5 (SMAW)
- 3). OBG Field Splice 7E/8E A Longitudinal Stiffener (LS) 5 (SMAW)
- 4). OBG Field Splice 6E/7E Weld ID: B1, Face B – (R-2 Repair Excavating and SMAW)
- 5). OBG

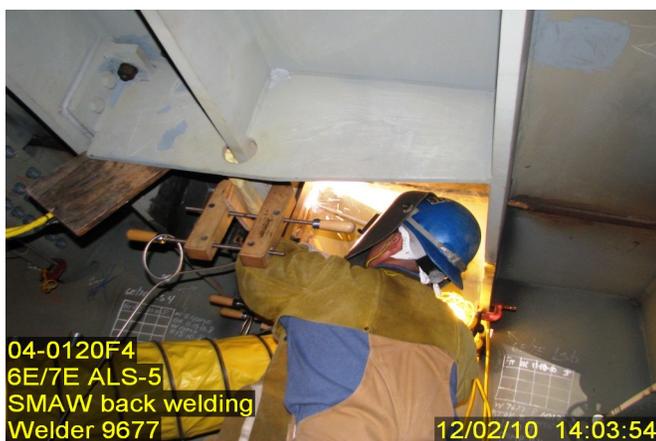
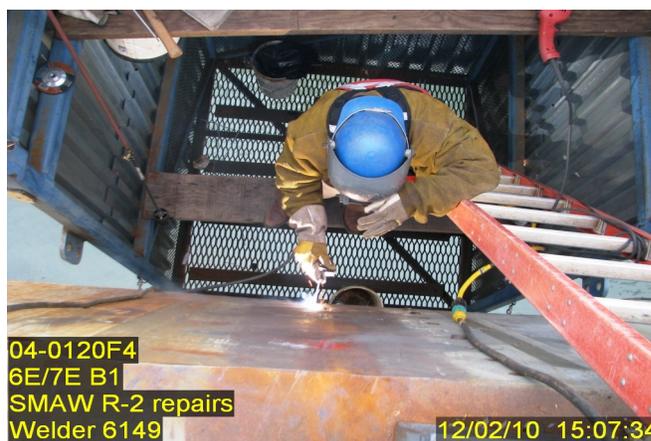
The QAI periodically observed AB/F approved welder Xiao Jian Wan (ID 9677) performing back welding of fill and cover pass per the Shielded Metal Arc Welding (SMAW) process in the 3G (vertical) position of OBG Field

Splice 6E/7E ALS-5. See photo below. QC Inspector John Pagliero was present periodically to monitor the progress and verify that the welding parameters were within the limits established by the approved welding Procedure Specification (WPS) identified as ABF-WPS-D1.5-1012-3. The welding was completed at this location and appeared to be in general compliance with contract documents.
