Contract #: 04-0120F4Cty: SF/ALA Rte: 80 PM: 13.2/13.9File #: 69.28**WELDING INSPECTION REPORT****Resident Engineer:** Siegenthaler, Peter**Address:** 333 Burma Road**City:** Oakland, CA 94607**Report No:** WIR-018496**Date Inspected:** 03-Dec-2010**Project Name:** SAS Superstructure**OSM Arrival Time:** 700**Prime Contractor:** American Bridge/Fluor Enterprises, a JV**OSM Departure Time:** 1900**Contractor:** Zhenhua Port Machinery Company, Ltd (ZPMC), Changxing Island **Location:** Shanghai, China**CWI Name:** Lv Li Qing**CWI Present:** Yes No**Inspected CWI report:** Yes No N/A**Rod Oven in Use:** Yes No N/A**Electrode to specification:** Yes No N/A**Weld Procedures Followed:** Yes No N/A**Qualified Welders:** Yes No N/A**Verified Joint Fit-up:** Yes No N/A**Approved Drawings:** Yes No N/A**Approved WPS:** Yes No N/A**Delayed / Cancelled:** Yes No N/A**Bridge No:** 34-0006**Component:** OBG**Summary of Items Observed:**

WELDING INSPECTION REPORT

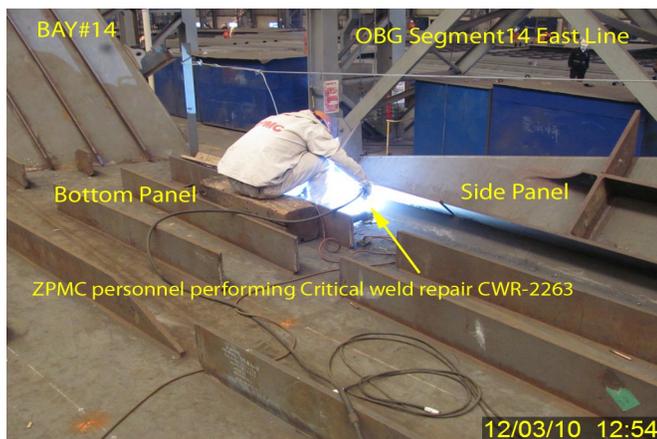
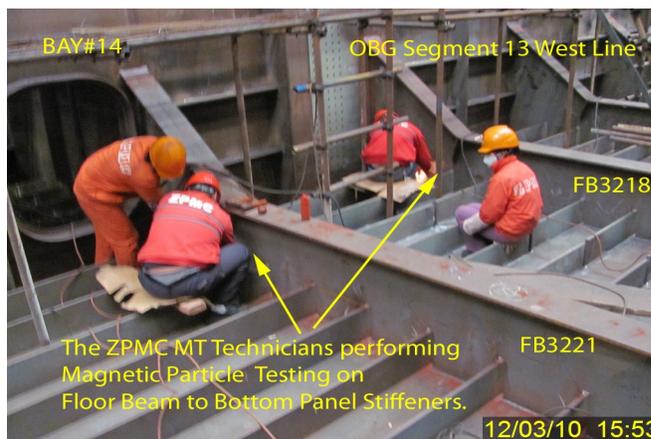
FCAW welding of weld joint no: SEG3019A-009 located on OBG Segment 14E Bottom Panel to Side Panel. Welder is identified as #044824. ZPMC CWI is identified as Mr.Lv Li Qing. Welding was performed according to the Critical weld repair report C-WR2263. The welding variables recorded by QC appeared to comply with the WPS-345-FCAW-1G-ESAB-Repair. Please see the attached picture.
