Contract #: 04-0120F4Cty: SF/ALA Rte: 80 PM: 13.2/13.9File #: 82.28**WELDING INSPECTION REPORT****Resident Engineer:** Siegenthaler, Peter**Address:** 333 Burma Road**City:** Oakland, CA 94607**Report No:** WIR-018574**Date Inspected:** 04-Dec-2010**Project Name:** SAS Superstructure**OSM Arrival Time:** 500**Prime Contractor:** American Bridge/Fluor Enterprises, a JV**OSM Departure Time:** 1330**Contractor:** Westmont Industries**Location:** Santa Fe Springs, CA.**CWI Name:** Ruben Dominguez**CWI Present:** Yes No**Inspected CWI report:** Yes No N/A**Rod Oven in Use:** Yes No N/A**Electrode to specification:** Yes No N/A**Weld Procedures Followed:** Yes No N/A**Qualified Welders:** Yes No N/A**Verified Joint Fit-up:** Yes No N/A**Approved Drawings:** Yes No N/A**Approved WPS:** Yes No N/A**Delayed / Cancelled:** Yes No N/A**Bridge No:** 34-0006**Component:** Travelers**Summary of Items Observed:**

SAS-EB Traveler**Fixed Stairs Section**

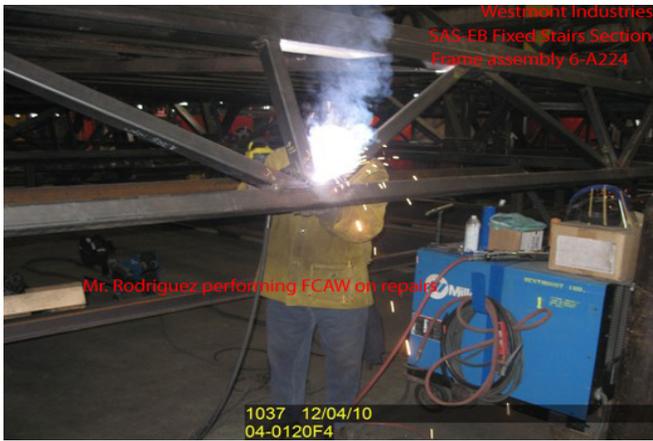
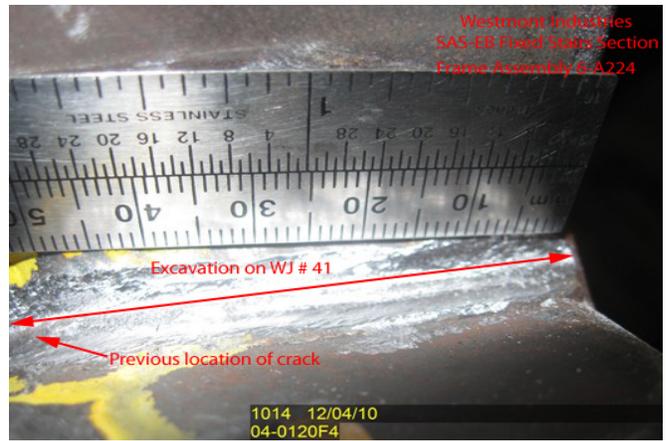
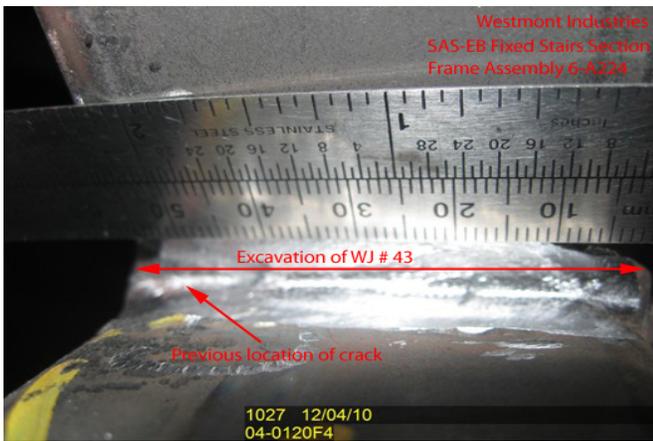
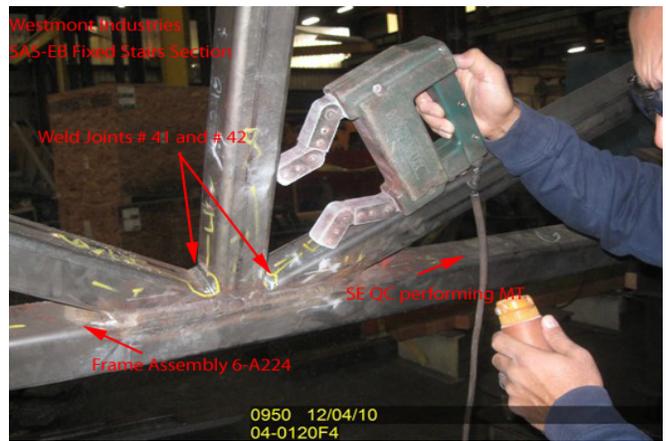
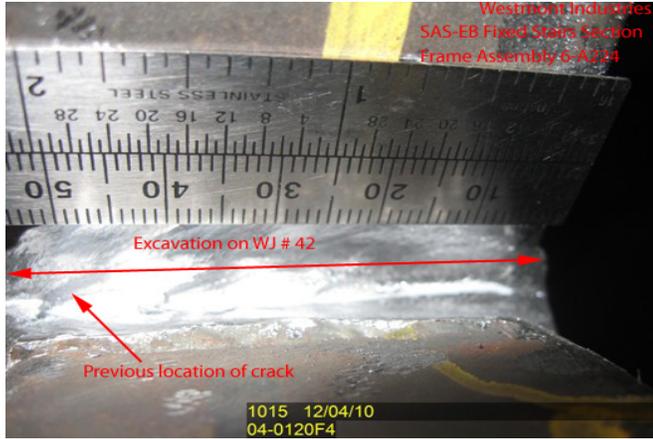
See attached pictures below.

On this date, the QA Inspector observed Westmont Industries (WMI) production welder, Mr. Jose Rodriguez (WID # 3031), continuing to perform Flux Core Arc Welding (FCAW) activities on the previously fit Frame assemblies, identified as 10-A237, 11-B237, 3-A217, 4-A218, 5-A223 and 6-A224. The QA Inspector observed that the FCAW was being performed in various positions, on the connector plate and Tube Steel (TS) material fillet and flare groove welds. Additionally, the QA Inspector observed Mr. Rodriguez performing grinding and FCAW activities on the previously discovered crater cracks on 3 fillet welds, identified as weld joints # 41, # 42 and # 43, on the Frame Assembly identified as 6-A224. The QA Inspector initially observed Mr. Rodriguez utilizing a grinder with an attached burring bit to begin excavation activities on the above mentioned weld joints. During observation, the QA Inspector observed Mr. Rodriguez perform the first excavation on the weld joint identified as # 43. After the excavation was complete, the QA Inspector then observed SE QC Inspector Ruben Dominguez then perform Visual and Magnetic Particle Testing (VT/MT) on the excavated area. The QA Inspector

observed that 50 mm of weld material had been removed beyond the end of the crater crack. After performing the VT/MT, Mr. Dominguez explained that no rejectable indications were found, during testing. The QA Inspector then observed Mr. Rodriguez perform excavation in the same manner on the weld joint identified as # 42. After the excavation was complete, the QA Inspector observed Mr. Dominguez perform VT/MT on the excavated area. During the MT testing, Mr. Dominguez explained that rejectable indications were found. Mr. Dominguez then instructed Mr. Rodriguez to perform additional grinding on the weld joint. After further grinding, the QA Inspector observed Mr. Dominguez then perform additional MT on the excavation. After the MT was complete, Mr. Dominguez explained that no rejectable indications were found. The QA Inspector then observed Mr. Rodriguez performing the third and final excavation on the weld joint identified as # 43. Once the excavation appeared to be complete, the QA Inspector observed Mr. Dominguez performing VT/MT on the excavated area. After testing, Mr. Dominguez explained that no rejectable indications were found.

The QA Inspector then observed Mr. Rodriguez utilizing the Flux Core Arc Welding (FCAW) process to perform the welding repairs. The QA Inspector observed that the approved WMI Welding Procedure Specification (WPS) W114 appeared to be nearby the work area and appeared to be listed as the WPS to be utilized for the weld repairs on Form # ABFWEST-QC-117, Request for Weld Repair Approval. After the FCAW was complete, the QA Inspector observed Mr. Dominguez performing 100% VT on the completed welds, utilizing a Bridge Cam Gauge and flashlight. Mr. Dominguez then explained that no rejectable indications were found, after testing. After cooling to ambient temperature, the QA Inspector observed Mr. Dominguez then perform 100 % final MT on the three repairs. After testing, Mr. Dominguez explained that no rejectable indications were found and an applicable Form ABFWEST-QC-115, Weld Repair Report will be completed on this date.

The QA Inspector then performed 100% MT on the above mentioned weld repairs and found no rejectable indications after testing. See completed TL6028, for additional details. The QA Inspector noted that prior to performing the above mentioned repairs, that WMI had previously submitted the applicable Form ABFWEST-QC-117, Request for Weld Repair Approval (Submittal # 002008 Rev. # 00) and that ABFJV engineer had been notified, prior to performing the repairs. The QA Inspector also noted that the Submittal had been previously Approved as Noted and WMI had been given a METS verbal to proceed with the repairs, with the understanding that WMI perform the required changes on the submittal. The QA Inspector noted that the above mentioned weld repairs appeared to have been performed in accordance to AWS D1.1 2002 and the approved WMI Repair Procedure.
