DEPARTMENT OF TRANSPORTATION

Contract #: 04-0120F4Cty: SF/ALA Rte: 80 PM: 13.2/13.9File #: 69.28**WELDING INSPECTION REPORT****Resident Engineer:** Siegenthaler, Peter**Address:** 333 Burma Road**City:** Oakland, CA 94607**Report No:** WIR-018575**Date Inspected:** 13-Dec-2010**Project Name:** SAS Superstructure**OSM Arrival Time:** 700**Prime Contractor:** American Bridge/Fluor Enterprises, a JV**OSM Departure Time:** 1900**Contractor:** Zhenhua Port Machinery Company, Ltd (ZPMC), Changxing Island **Location:** Shanghai, China

Bridge No: 34-0006**Component:** OBG COMPONENT**Summary of Items Observed:**

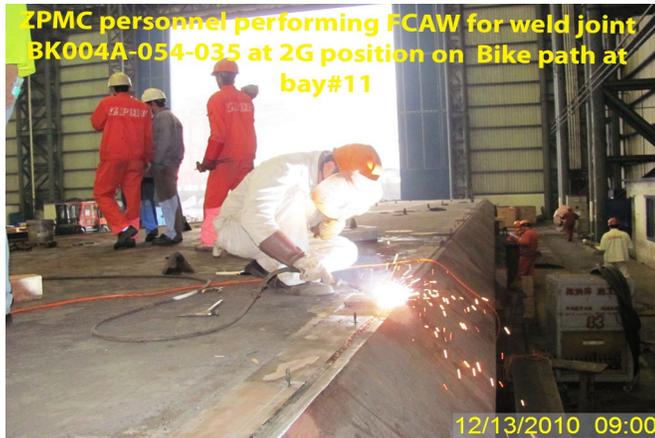
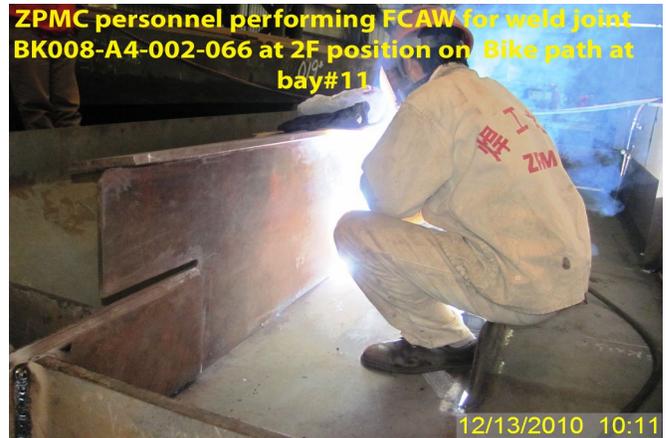
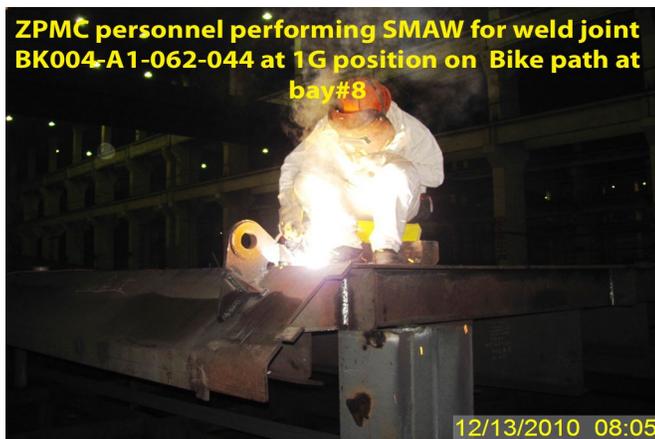
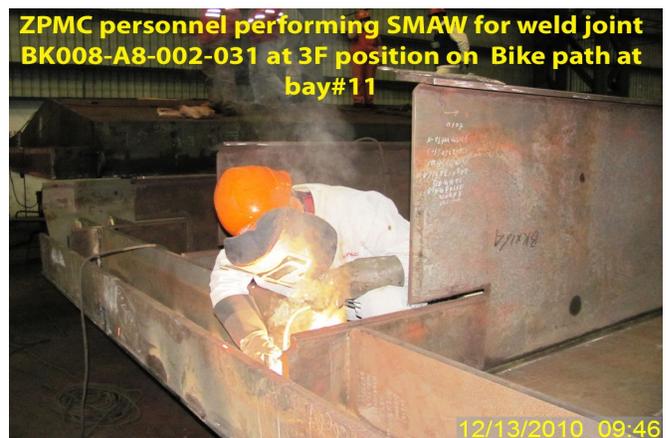
FCAW in the 1G position for the OBG bike path, weld No.BK004-A2-032-010. The welder is identified as #053869. ZPMC QC is identified as Mr. Guo Yan Fei. The welding variables recorded by QC appear to comply with WPS-B-T-2231-ESAB.

FCAW in the 1G position for the OBG bike path, weld No.BK004-A5-032-002. The welder is identified as #040533. ZPMC QC is identified as Mr. Guo Yan Fei. The welding variables recorded by QC appear to comply with WPS-B-T-2231-ESAB.

SMAW in the 2F position for the OBG Bike path, weld No.BK004A-020-MEP-026. The welder is identified as #040723. ZPMC QC is identified as Mr. Shao Hai Lang. The welding variables recorded by QC appear to comply

FMAW in the 2G position for the OBG Bike path , weld No.BK004-A1-054-042. The welder is identified as #040704. ZPMC QC is identified as Mr. Shao Hai Lang. The welding variables recorded by QC appear to comply with WPS-B-T-2232-ESAB.

SMAW in the 3F position for the OBG Bike path , weld No.BK008-A8-002-031. The welder is identified as #0407655. ZPMC QC is identified as Mr. Yu Dong Ping . The welding variables recorded by QC appear to comply with WPS-B-P-2113.

FCAW in the 2F position for the OBG Bike path , weld No.BK008-A4A-002-066. The welder is identified as #205649. ZPMC QC is identified as Mr. Yu Dong Ping. The welding variables recorded by QC appear to comply with WPS-B-T-2132-ESAB.

SMAW in the 1G position for the OBG bike path, weld No.BK004-A1-062-044. The welder is identified as #066155. ZPMC QC is identified as Mr. Liu Fa Wen. The welding variables recorded by QC appear to comply with WPS-B-P-2211-B-U2.

SMAW in the 1G position for the OBG bike path, UT repair weld No.BK004-A1-059-044. The welder is identified as #067904. ZPMC QC is identified as Mr. Liu Fa Wen. The welding variables recorded by QC appear to comply with WPS-345-smaw-1g(1f)-repair.
