DEPARTMENT OF TRANSPORTATION

Contract #: 04-0120F4Cty: SF/ALA Rte: 80 PM: 13.2/13.9File #: 99.28**WELDING INSPECTION REPORT****Resident Engineer:** Siegenthaler, Peter**Address:** 333 Burma Road**City:** Oakland, CA 94607**Report No:** WIR-018579**Date Inspected:** 13-Dec-2010**Project Name:** SAS Superstructure**OSM Arrival Time:** 700**Prime Contractor:** American Bridge/Fluor Enterprises, a JV**OSM Departure Time:** 1900**Contractor:** Zhenhua Port Machinery Company, Ltd (ZPMC)**Location:** Shanghai, China**CWI Name:** Li Yang and Zhu Zhong Hai**CWI Present:** Yes No**Inspected CWI report:** Yes No N/A**Rod Oven in Use:** Yes No N/A**Electrode to specification:** Yes No N/A**Weld Procedures Followed:** Yes No N/A**Qualified Welders:** Yes No N/A**Verified Joint Fit-up:** Yes No N/A**Approved Drawings:** Yes No N/A**Approved WPS:** Yes No N/A**Delayed / Cancelled:** Yes No N/A**Bridge No:** 34-0006**Component:** OBG Trial Assembly**Summary of Items Observed:**

Orthotropic Box Girder (OBG) at Trial Assembly Areas

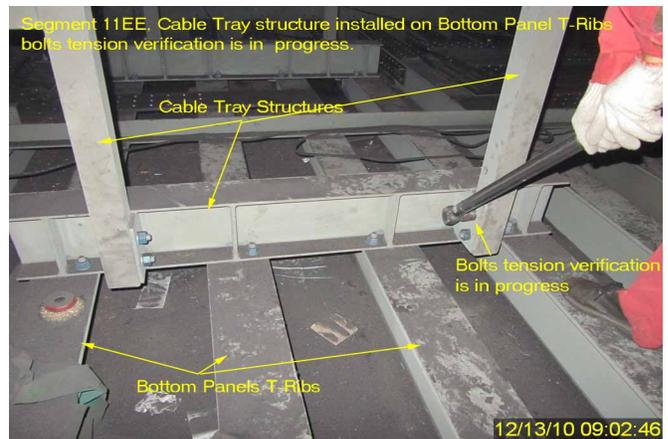
This Quality Assurance (QA) Inspector witnessed final bolt tension verification for cable tray structure installed at bottom panel between the Panel Points (PP) 95 to PP 96, PP 96 to PP 97 and PP 97 to PP 98 for Segment 11AE at North and South side. Inspected 10% on a random basis and found the tension to be in general compliance. Inspection was performed against the Notification No. 00570 Dated December 13, 2010.

This Quality Assurance (QA) Inspector witnessed final bolt tension verification for cable tray structure installed at bottom panel between the Panel Points (PP) 98.5 to PP 99 and PP 99.5 to PP 100 for Segment 11BE at North and South side. Inspected 10% on a random basis and found the tension to be in general compliance. Inspection was performed against the Notification No. 00570 Dated December 13, 2010.

This Quality Assurance (QA) Inspector witnessed final bolt tension verification for cable tray structure installed at bottom panel between the Panel Points (PP) 100 to PP 101; PP 101 to PP 102 and PP 102 to PP 103 for Segment 11CE at North and South side. Inspected 10% on a random basis and found the tension to be in general compliance. Inspection was performed against the Notification No. 00570 Dated December 13, 2010.

This Quality Assurance (QA) Inspector witnessed final bolt tension verification for cable tray structure installed at bottom panel between the Panel Points (PP) 103 to PP 104; PP 104.5 to PP105 and PP 105.5 to PP 106 for Segment 11DE at North and South side. Inspected 10% on a random basis and found the tension to be in general compliance. Inspection was performed against the Notification No. 00570 Dated December 13, 2010.

This Quality Assurance (QA) Inspector witnessed final bolt tension verification for cable tray structure installed at bottom panel between the Panel Points (PP) 106 to PP 107; PP 107 to PP 107.5 and PP 108 to PP108.75 for Segment 11EE at North and South side. Inspected 10% on a random basis and found the tension to be in general compliance. Inspection was performed against the Notification No. 00570 Dated December 13, 2010.

Please reference the pictures attached for more comprehensive details.
