DEPARTMENT OF TRANSPORTATION

Quality Assurance and Source Inspection

Contract #: 04-0120F4Cty: SF/ALA Rte: 80 PM: 13.2/13.9File #: 69.28**WELDING INSPECTION REPORT****Resident Engineer:** Siegenthaler, Peter**Address:** 333 Burma Road**City:** Oakland, CA 94607**Report No:** WIR-018625**Date Inspected:** 15-Dec-2010**Project Name:** SAS Superstructure**OSM Arrival Time:** 700**Prime Contractor:** American Bridge/Fluor Enterprises, a JV**OSM Departure Time:** 1900**Contractor:** Zhenhua Port Machinery Company, Ltd (ZPMC), Changxing Island **Location:** Shanghai, China**CWI Name:** Xu tao**CWI Present:** Yes No**Inspected CWI report:** Yes No N/A**Rod Oven in Use:** Yes No N/A**Electrode to specification:** Yes No N/A**Weld Procedures Followed:** Yes No N/A**Qualified Welders:** Yes No N/A**Verified Joint Fit-up:** Yes No N/A**Approved Drawings:** Yes No N/A**Approved WPS:** Yes No N/A**Delayed / Cancelled:** Yes No N/A**Bridge No:** 34-0006**Component:** OBG Components**Summary of Items Observed:**

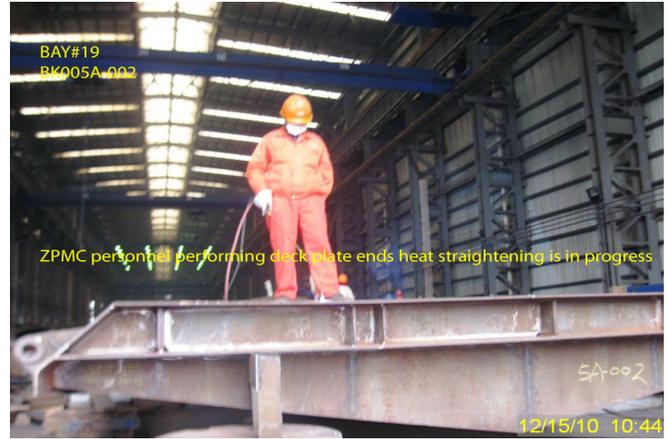
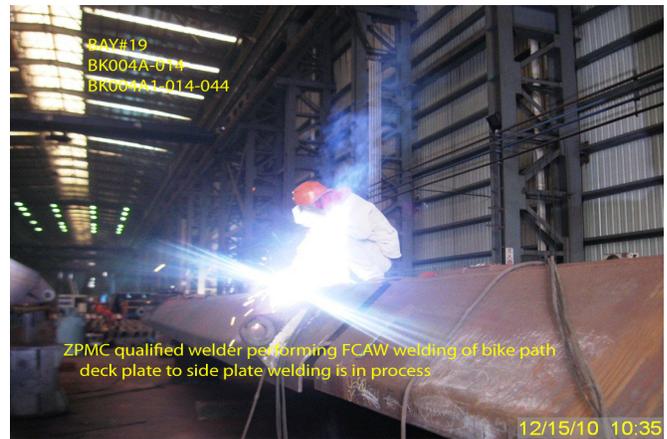
FCAW welding of weld is identified as 1G-044 of BK004A1-014 for BK004A-014. The welder is identified as 062808. ZPMC QC is identified as Mr. Xu tao. The welding variables recorded by QC are appeared to comply with the WPS-B-T-2231-ESAB.

SMAW welding of critical repair weld is identified as 2F-041,054,065 of SB018-098 for SB98W. The welder is identified as 062814. ZPMC QC is identified as Mr. Xu tao. The welding variables recorded by QC are appeared to comply with the WPS-345-SMAW-2F-Repair and B-CWR2475.

SMAW welding of critical repair weld is identified as 3F-026,028 of BK004A8-014 for BK004-014. The welder is identified as 062814. ZPMC QC is identified as Mr. Xu tao. The welding variables recorded by QC are appeared to comply with the WPS-345-SMAW-3F-Repair and B-CWR2474.

SMAW welding of critical repair weld is identified as 4F-129,037 of BK004A8-014 for BK004-014. The welder is identified as 062814. ZPMC QC is identified as Mr. Xu tao. The welding variables recorded by QC are appeared to comply with the WPS-345-SMAW-4F-Repair and B-CWR2474.

ZPMC personnel performing Heat straightening of bike path deck plate end is in progress. The bike path is

identified as BK005A-002 is appeared to comply with HSR1 (B)-09894.

During Quality Assurance random in-process observations of the fabrication of OBG Lift 11 Suspender brackets SB108E, this Caltrans Quality Assurance (QA) inspector discovered the following issue:

- The joint design of Three (3) complete joint penetration weld joints do not comply with the weld details specified on the approved shop drawing.
- According to the approved weld details drawing, the bevel is on the arrow side.
- ZPMC personnel prepare the bevel face on the other side of the arrow.
