DEPARTMENT OF TRANSPORTATION

Quality Assurance and Source Inspection

Contract #: 04-0120F4Cty: SF/Ala Rte: 80 PM: 13.2/13.9File #: 69.28**WELDING INSPECTION REPORT****Resident Engineer:** Siegenthaler, Peter**Address:** 333 Burma Road**City:** Oakland, CA 94607**Report No:** WIR-018700**Date Inspected:** 07-Dec-2010**Project Name:** SAS Superstructure**OSM Arrival Time:** 1900**Prime Contractor:** American Bridge/Fluor Enterprises, a JV**OSM Departure Time:** 700**Contractor:** Zhenhua Port Machinery Company, Ltd (ZPMC), Changxing Island **Location:** Shanghai, China**CWI Name:** See below**CWI Present:** Yes No**Inspected CWI report:** Yes No N/A**Rod Oven in Use:** Yes No N/A**Electrode to specification:** Yes No N/A**Weld Procedures Followed:** Yes No N/A**Qualified Welders:** Yes No N/A**Verified Joint Fit-up:** Yes No N/A**Approved Drawings:** Yes No N/A**Approved WPS:** Yes No N/A**Delayed / Cancelled:** Yes No N/A**Bridge No:** 34-0006**Component:** Tower and OBG Components**Summary of Items Observed:**

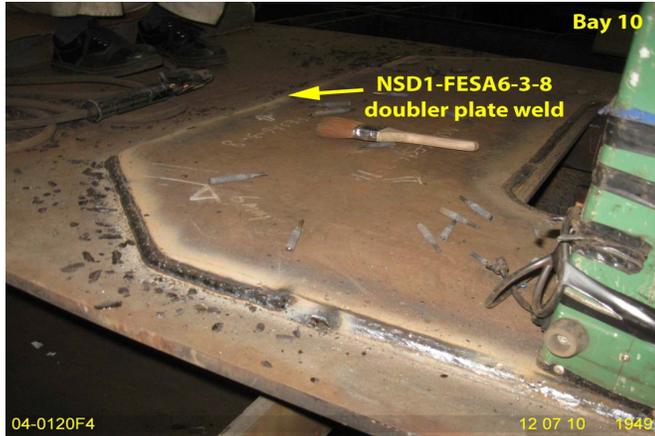
SMAW welding of joints NSD1-FESA6-3-8 located on PCMK north tower, lift 6, skin E, doubler plate. See photo below. Welders were identified as 056364, 040268. QC was identified as QC1. Assisting QC1 at this location and appearing to be monitoring the welding operation and recording data was QCA1, who was not a CWI. Welding variables recorded by QCA1 appeared to comply with WPS-B-T-2132-TC-P4-F as verbally identified by
