DEPARTMENT OF TRANSPORTATION

Quality Assurance and Source Inspection

Contract #: 04-0120F4Cty: SF/ALA Rte: 80 PM: 13.2/13.9File #: 1.28**WELDING INSPECTION REPORT****Resident Engineer:** Siegenthaler, Peter**Address:** 333 Burma Road**City:** Oakland, CA 94607**Report No:** WIR-018802**Date Inspected:** 20-Dec-2010**Project Name:** SAS Superstructure**OSM Arrival Time:** 630**Prime Contractor:** American Bridge/Fluor Enterprises, a JV**OSM Departure Time:** 1500**Contractor:** American Bridge/Fluor Enterprises, a JV**Location:** Job Site**CWI Name:** See Below**CWI Present:** Yes No**Inspected CWI report:** Yes No N/A**Rod Oven in Use:** Yes No N/A**Electrode to specification:** Yes No N/A**Weld Procedures Followed:** Yes No N/A**Qualified Welders:** Yes No N/A**Verified Joint Fit-up:** Yes No N/A**Approved Drawings:** Yes No N/A**Approved WPS:** Yes No N/A**Delayed / Cancelled:** Yes No N/A**Bridge No:** 34-0006**Component:** Orthotropic Box Girders**Summary of Items Observed:**

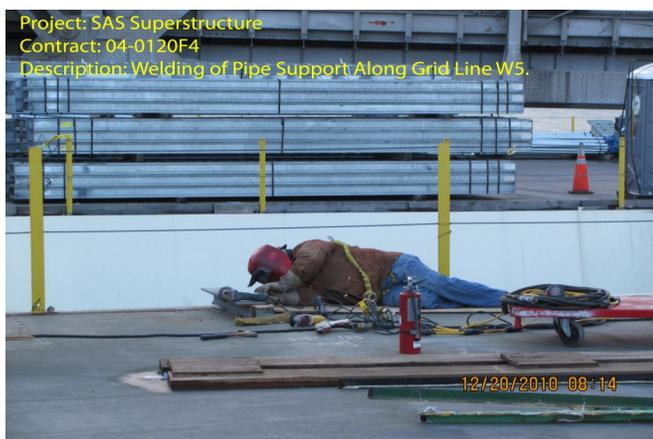
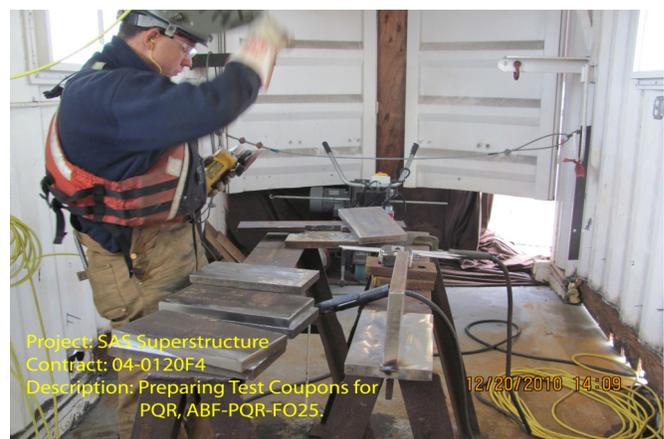
The QAI observed the fillet welding of the pipe supports along the W5 grid line located on top side of the OBG W3 "A" deck. The QC inspection was performed by Mike Johnson utilizing the Welding Procedure Specification (WPS) identified as Fillet Murex to monitor the welding and to verify the welding parameters. The welding parameters were observed and recorded as 94 amps utilizing 2.4 mm electrodes with the welding performed in the 2F and 3F position. The Welding was performed by David Garcia ID-8789.

The QAI also observed the fillet welding of the pipe supports along the E5 grid line located on top side of the OBG W7 "A" deck. The QC inspection was performed by Mike Johnson utilizing the Welding Procedure Specification (WPS) identified as Fillet Murex to monitor the welding and to verify the welding parameters. The welding parameters were observed and recorded as 99 amps utilizing 2.4 mm electrodes with the welding performed in the 2F and 3F position. The Welding was performed by Rick Kiikvee ID-5319

The QAI observed the preparation of three (3) test plate assemblies. The preparation of the test plates included removing rust and mill scale from the surfaces to be welded, the fit-up and tack welding of the test plates. This task was performed by Rick Clayborn, ID-2773, as per the Procedure Qualification Test Record (PQTR) identified as ABF-PQR-FO25. Mr. Clayborn was assisted by Ian Murphy.

The digital photographs below illustrate the work observed during this scheduled shift.
