DEPARTMENT OF TRANSPORTATION

Quality Assurance and Source Inspection

Contract #: 04-0120F4Cty: SF/ALA Rte: 80 PM: 13.2/13.9File #: 69.28**WELDING INSPECTION REPORT****Resident Engineer:** Siegenthaler, Peter**Address:** 333 Burma Road**City:** Oakland, CA 94607**Report No:** WIR-018805**Date Inspected:** 16-Dec-2010**Project Name:** SAS Superstructure**OSM Arrival Time:** 700**Prime Contractor:** American Bridge/Fluor Enterprises, a JV**OSM Departure Time:** 1900**Contractor:** Zhenhua Port Machinery Company, Ltd (ZPMC), Changxing Island **Location:** Shanghai, China**CWI Name:** Zhu Zhong Hai**CWI Present:** Yes No**Inspected CWI report:** Yes No N/A**Rod Oven in Use:** Yes No N/A**Electrode to specification:** Yes No N/A**Weld Procedures Followed:** Yes No N/A**Qualified Welders:** Yes No N/A**Verified Joint Fit-up:** Yes No N/A**Approved Drawings:** Yes No N/A**Approved WPS:** Yes No N/A**Delayed / Cancelled:** Yes No N/A**Bridge No:** 34-0006**Component:** Orthotropic Box Girder (OBG)**Summary of Items Observed:**

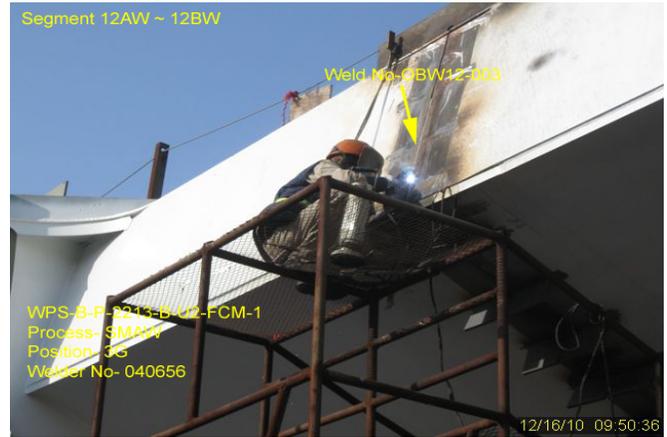
This QA Inspector observed ZPMC qualified welding personnel identified as 040656 perform Shielded Metal Arc Welding (SMAW), weld joint identified as OBE12-003; located On Orthotropic Box Girder (OBG) Edge Plate to Edge Plate CJP Weld; ZPMC Quality Control (QC) is identified as Mr. Liu Hua Jie. The welding variables recorded by QC appeared to comply with applicable WPS-B-P-2213-B-U2-FCM-1. See attached photo for further details.
