Contract #: 04-0120F4Cty: SF/ALA Rte: 80 PM: 13.2/13.9File #: 69.28**WELDING INSPECTION REPORT****Resident Engineer:** Siegenthaler, Peter**Address:** 333 Burma Road**City:** Oakland, CA 94607**Report No:** WIR-018827**Date Inspected:** 22-Dec-2010**Project Name:** SAS Superstructure**OSM Arrival Time:** 700**Prime Contractor:** American Bridge/Fluor Enterprises, a JV**OSM Departure Time:** 1900**Contractor:** Zhenhua Port Machinery Company, Ltd (ZPMC), Changxing Island **Location:** Shanghai, China**CWI Name:** Mr. Tian lei**CWI Present:** Yes No**Inspected CWI report:** Yes No N/A**Rod Oven in Use:** Yes No N/A**Electrode to specification:** Yes No N/A**Weld Procedures Followed:** Yes No N/A**Qualified Welders:** Yes No N/A**Verified Joint Fit-up:** Yes No N/A**Approved Drawings:** Yes No N/A**Approved WPS:** Yes No N/A**Delayed / Cancelled:** Yes No N/A**Bridge No:** 34-0006**Component:** Orthotropic Box Girder (OBG)**Summary of Items Observed:**

WELDING INSPECTION REPORT

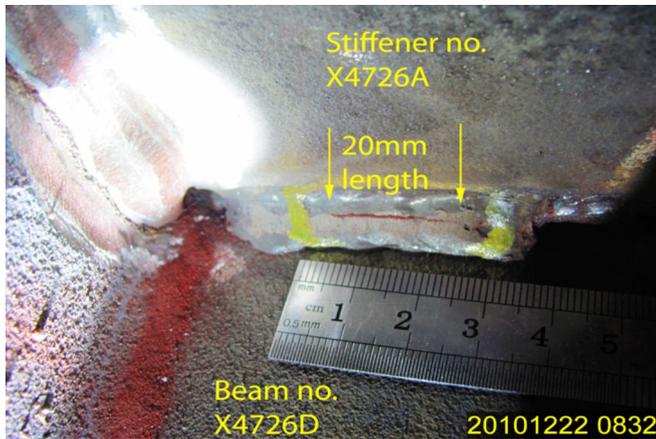
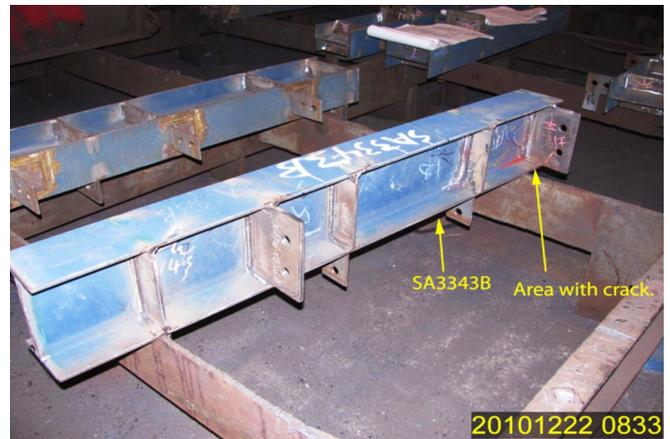
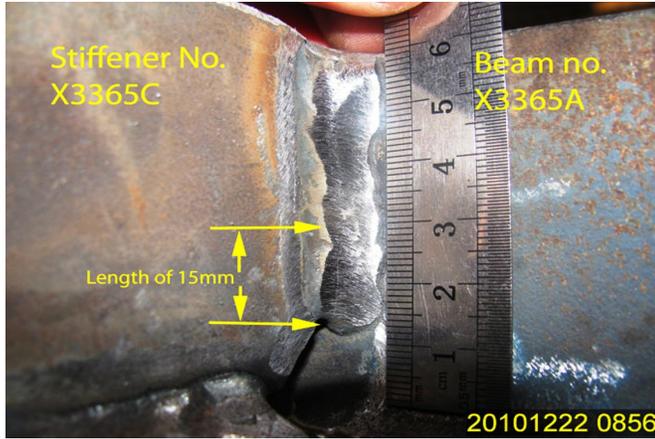
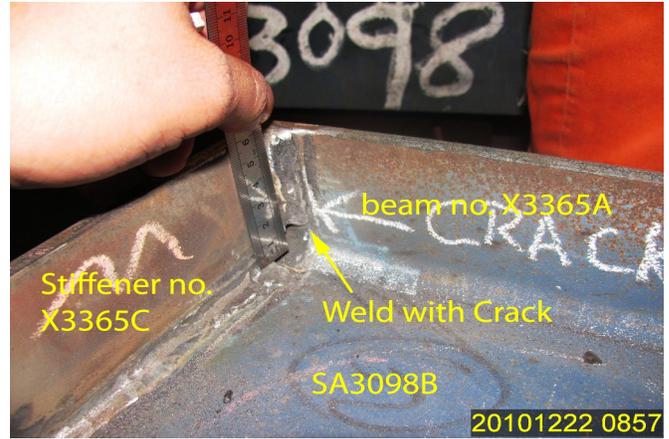
During the QA VT examination this QA Inspector observed multiple cracks were discovered in fillet welds. These components are vertical corner fillet welds identified as follows:

- 1) SA3098B that joins stiffeners X3365C to X3365A.
- 2) SA3343B that joins stiffeners X4726A to X4726D.

These cracks are located within the area that has been previously tested and accepted by ZPMC Quality Control (QC) personnel. As per the contract documents, ZPMC QC personnel are required to perform 100% VT inspection of these welds.

ZPMC Certified Welding Inspector (CWI) identified as Mr. Tian lei informed this QA that the cracked components would be corrected in a manner compliant with the contract documents and this whole lot (item#2) will be re tested by VT and Magnetic Particle Testing. After completion of all repair work ZPMC will be re notified for the inspection.
