**DEPARTMENT OF TRANSPORTATION**

Contract #: 04-0120F4Cty: SF/ALA Rte: 80 PM: 13.2/13.9File #: 69.28**WELDING INSPECTION REPORT****Resident Engineer:** Siegenthaler, Peter**Address:** 333 Burma Road**City:** Oakland, CA 94607**Report No:** WIR-018832**Date Inspected:** 16-Dec-2010**Project Name:** SAS Superstructure**OSM Arrival Time:** 700**Prime Contractor:** American Bridge/Fluor Enterprises, a JV**OSM Departure Time:** 1900**Contractor:** Zhenhua Port Machinery Company, Ltd (ZPMC), Changxing Island **Location:** Shanghai, China**CWI Name:** Mr. Li jia**CWI Present:** Yes No**Inspected CWI report:** Yes No N/A**Rod Oven in Use:** Yes No N/A**Electrode to specification:** Yes No N/A**Weld Procedures Followed:** Yes No N/A**Qualified Welders:** Yes No N/A**Verified Joint Fit-up:** Yes No N/A**Approved Drawings:** Yes No N/A**Approved WPS:** Yes No N/A**Delayed / Cancelled:** Yes No N/A**Bridge No:** 34-0006**Component:** Orthotropic Box Girder (OBG)**Summary of Items Observed:**

# WELDING INSPECTION REPORT

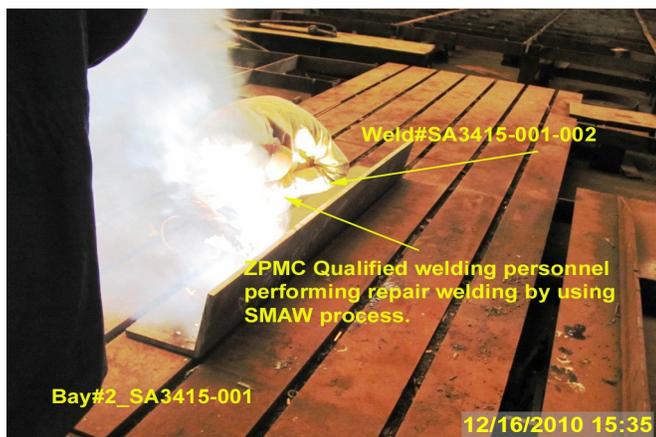
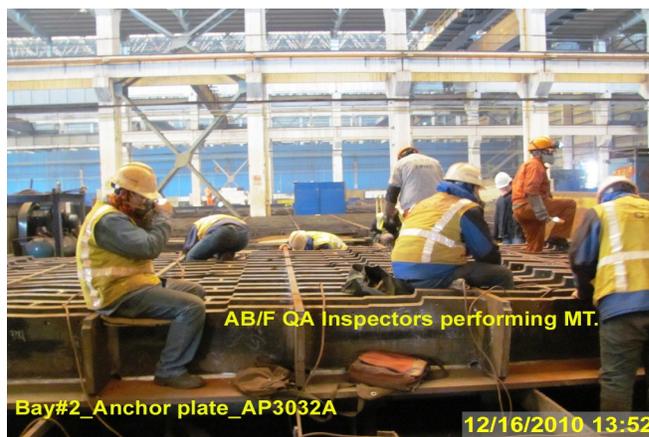
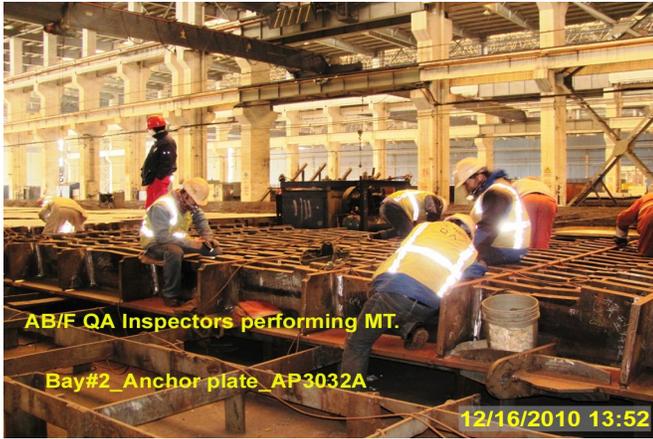
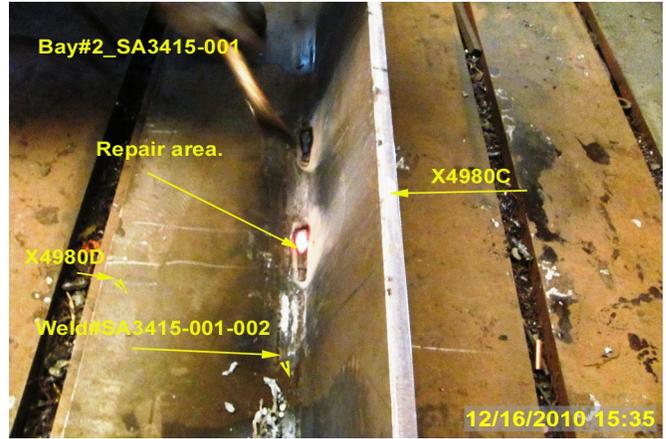
American Bridge/ Fluor QA Inspectors performing Magnetic Particle Testing (MT) for the welds located on the Anchor plate identified as AP3032A.MT was being performed after completion of all transverse cracks repair welding. Refer the attached photos for reference.

Shielded Metal Arc Welding (SMAW) Repair welding of weld joint SA3415-001-002. Welder is identified as 066002. ZPMC Quality Control (QC) is identified as Mr. Wang liyang. The welding variables appeared to comply with the Applicable WPS: WPS-345-SMAW-2G (2F)-Repair. The repair welding was being performed as per the Welding Repair Report (WRR) No: B-WR1867 Rev.1.This weld was rejected by ZPMC UT Technicians and recorded on UT report No: B787-UT-17784.Refer the attached photos for reference.
