Contract #: 04-0120F4Cty: SF/ALA Rte: 80 PM: 13.2/13.9File #: 99.28**WELDING INSPECTION REPORT****Resident Engineer:** Siegenthaler, Peter**Address:** 333 Burma Road**City:** Oakland, CA 94607**Report No:** WIR-018880**Date Inspected:** 23-Dec-2010**Project Name:** SAS Superstructure**OSM Arrival Time:** 700**Prime Contractor:** American Bridge/Fluor Enterprises, a JV**OSM Departure Time:** 1900**Contractor:** Zhenhua Port Machinery Company, Ltd (ZPMC)**Location:** Shanghai, China**CWI Name:** Li Yang and Zhu Zhong Hai**CWI Present:** Yes No**Inspected CWI report:** Yes No N/A**Rod Oven in Use:** Yes No N/A**Electrode to specification:** Yes No N/A**Weld Procedures Followed:** Yes No N/A**Qualified Welders:** Yes No N/A**Verified Joint Fit-up:** Yes No N/A**Approved Drawings:** Yes No N/A**Approved WPS:** Yes No N/A**Delayed / Cancelled:** Yes No N/A**Bridge No:** 34-0006**Component:** OBG Trial Assembly**Summary of Items Observed:**

Orthotropic Box Girder (OBG) at Trial Assembly Areas

## WELDING INSPECTION REPORT

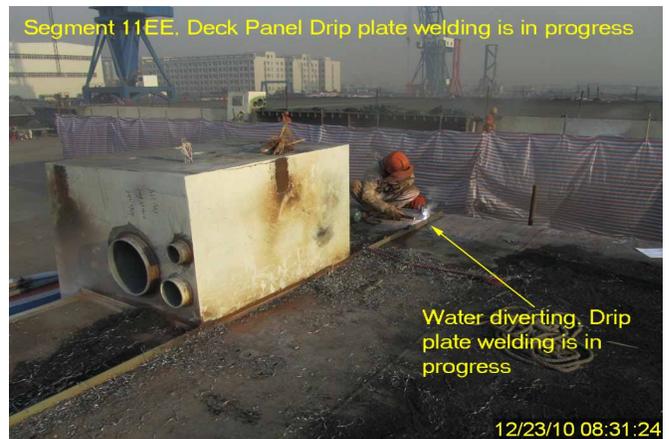
### Segment 11EE (Deck Panel Drip Plate)

This QA Inspector observed the Shielded Metal Arc Welding (SMAW) process on a Fillet weld. The weld joint was designated as OBE11E-140/141. The welder identification was 040270 and was observed welding in the 2F (Horizontal) position using approved Welding Procedure Specification WPS-B-P-2214-FCM-1. The piece mark was identified as the Drip plate welded at Deck Panel Corner Assembly, Cross Beam side.
