Contract #: 04-0120F4Cty: SF/ALA Rte: 80 PM: 13.2/13.9File #: 1.28**WELDING INSPECTION REPORT****Resident Engineer:** Siegenthaler, Peter**Address:** 333 Burma Road**City:** Oakland, CA 94607**Report No:** WIR-018906**Date Inspected:** 23-Dec-2010**Project Name:** SAS Superstructure**OSM Arrival Time:** 630**Prime Contractor:** American Bridge/Fluor Enterprises, a JV**OSM Departure Time:** 1500**Contractor:** American Bridge/Fluor Enterprises, a JV**Location:** Job Site

WELDING INSPECTION REPORT

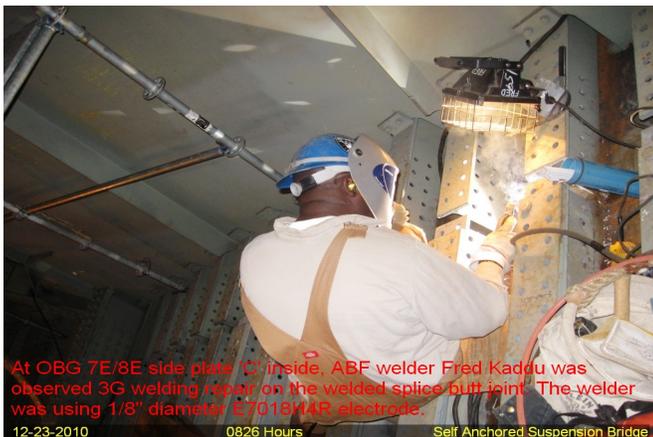
At OBG 7E/8E side plate 'C' inside, QA randomly observed ABF/JV qualified welder Fred Kaddu ID # 2188 continuing to perform CJP groove welding repair. The welder was observed welding in the 3G (vertical) position utilizing Shielded metal Arc Welding (SMAW) with 1/8" diameter E7018H4R electrode implementing welding procedure ABF-WPS-D15-1001-Repairs. The boat shape repair excavations having various dimensions were preheated to more than 140 degree Fahrenheit using propane gas torch prior welding. During the shift, ABF QC Fred Von Hoff was noted monitoring the welder. Prior welding, ABF QC John Pagliero was also observed performing Magnetic Particle Testing (MT). There were no defects noted during the test. The following first time repairs were noted excavated and completely welded at the end of the shift;

Shielded Metal Arc Welding (SMAW) back welding fill pass on the infill plate to top deck plate butt joint. The welder was noted using 1/8" diameter E7018H4R electrode. At the end of the shift, fill pass welding was still in progress and should continue tomorrow.

2. At OBG 3W-PP19.5-W5-S inside - ABF welder Han Wen Yu was observed continuing to perform 4G Shielded Metal Arc Welding (SMAW) back welding fill pass on the infill plate to top deck plate butt joint. The welder was noted using 1/8" diameter E7018H4R electrode. At the end of the shift, fill pass welding was still in progress and should continue tomorrow.

3. At OBG 3W-PP19.5-W2-N inside – ABF welder Mick Chan was observed continuing to perform 4G Shielded Metal Arc Welding (SMAW) back welding fill pass on the infill plate to top deck plate butt joint. The welder was noted using 1/8" diameter E7018H4R electrode. At the end of the shift, fill pass welding was still in progress and should continue tomorrow.

4. At OBG 3W-PP61.5-W5-S outside - ABF welder Jorge Lopez was observed 1G Shielded Metal Arc Welding (SMAW) welding fill pass on the infill plate to top deck plate. The welder was noted using 5/32" diameter E7018H4R electrode. At the end of the shift, fill pass welding on this location was still continuing which should remain tomorrow.
