Contract #: 04-0120F4Cty: SF/ALA Rte: 80 PM: 13.2/13.9File #: 69.28**WELDING INSPECTION REPORT****Resident Engineer:** Siegenthaler, Peter**Address:** 333 Burma Road**City:** Oakland, CA 94607**Report No:** WIR-018942**Date Inspected:** 07-Dec-2010**Project Name:** SAS Superstructure**OSM Arrival Time:** 700**Prime Contractor:** American Bridge/Fluor Enterprises, a JV**OSM Departure Time:** 1900**Contractor:** Zhenhua Port Machinery Company, Ltd (ZPMC), Changxing Island **Location:** Shanghai, China**CWI Name:** Mr. Xu Le Feng**CWI Present:** Yes No**Inspected CWI report:** Yes No N/A**Rod Oven in Use:** Yes No N/A**Electrode to specification:** Yes No N/A**Weld Procedures Followed:** Yes No N/A**Qualified Welders:** Yes No N/A**Verified Joint Fit-up:** Yes No N/A**Approved Drawings:** Yes No N/A**Approved WPS:** Yes No N/A**Delayed / Cancelled:** Yes No N/A**Bridge No:** 34-0006**Component:** Tower / OBG**Summary of Items Observed:**

WELDING INSPECTION REPORT

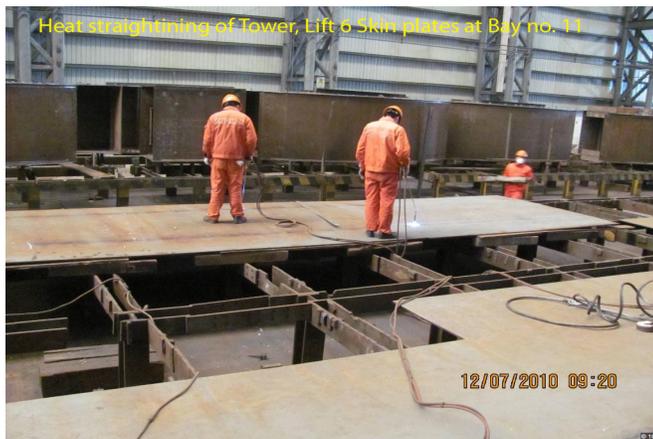
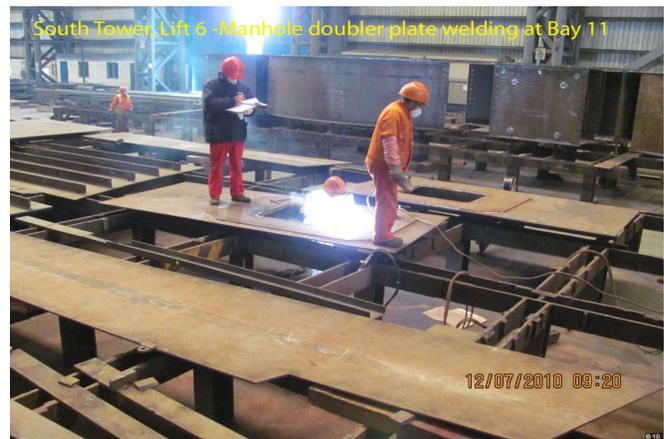
For further information see below pictures:-

Unless otherwise noted, all work observed on this date appeared to be in general compliance with the applicable contract documents.
