Contract #: 04-0120F4Cty: SF/ALA Rte: 80 PM: 13.2/13.9File #: 69.28**WELDING INSPECTION REPORT****Resident Engineer:** Siegenthaler, Peter**Address:** 333 Burma Road**City:** Oakland, CA 94607**Report No:** WIR-018953**Date Inspected:** 09-Dec-2010**Project Name:** SAS Superstructure**OSM Arrival Time:** 700**Prime Contractor:** American Bridge/Fluor Enterprises, a JV**OSM Departure Time:** 1900**Contractor:** Zhenhua Port Machinery Company, Ltd (ZPMC), Changxing Island **Location:** Shanghai, China**CWI Name:** Xu Le Feng**CWI Present:** Yes No**Inspected CWI report:** Yes No N/A**Rod Oven in Use:** Yes No N/A**Electrode to specification:** Yes No N/A**Weld Procedures Followed:** Yes No N/A**Qualified Welders:** Yes No N/A**Verified Joint Fit-up:** Yes No N/A**Approved Drawings:** Yes No N/A**Approved WPS:** Yes No N/A**Delayed / Cancelled:** Yes No N/A**Bridge No:** 34-0006**Component:** TOWER Components**Summary of Items Observed:**

WEST TOWER LIFT-5

WELDING INSPECTION REPORT

NORTH TOWER LIFT-5

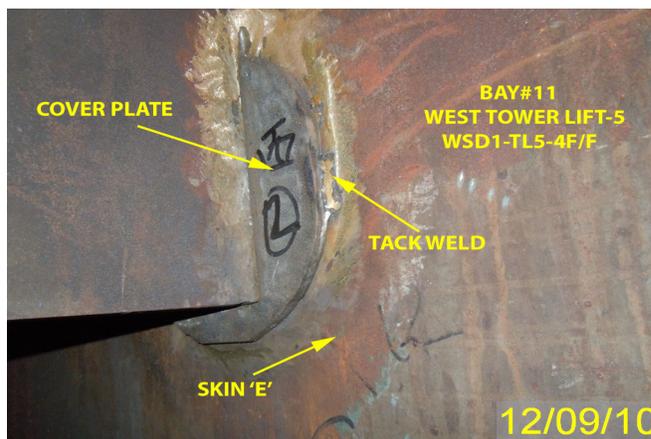
During the Caltrans Quality Assurance (QA) in-process observation on West tower lift-5 cover plate; this QA Inspector discovered the following issue:

- ZPMC fabrication personnel removed 2 cover plates including a total four (4) Non-SPCM fillet welds without engineer notification.
- And re-welded with new cover plates, where the dimension of the cover plate does not comply with the approved drawings.
- As per the shop drawing the required length of the cover plate is 151.4 mm.
- But the length measured to be approximately 212 mm.
- Welds are fillet welds joining cover plate to skin 'E'.
- The weld designations are WSD1-TL5-4F/F#13; 14; 15; 16.
- This component located at fabrication Bay#11.

AWS D1.5 2002 Section 3.7.5: "The Engineer shall be notified before improperly fitted and welded members are cut apart".

Approved Shop Drawing: "WSD1-TL5-4F-F".

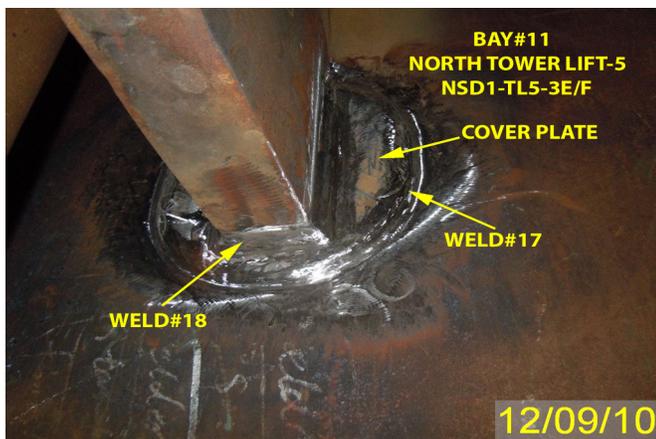
During the Caltrans Quality Assurance (QA) in-process observation on North tower lift-5 Cover plate, this QA Inspector discovered the following issue:

- ZPMC fabrication personnel removed 2 cover plates including a total four (4) Non-SPCM fillet welds without engineer notification.
- And re-welded with new cover plates, where the dimension of the cover plate does not comply with the approved drawings.
- As per the shop drawing the required length of the cover plate is 151.4 mm.
- But the length measured to be approximately 212 mm.
- Welds are fillet welds joining cover plate to skin 'E'.
- The weld designations are NSD1-TL5-3E/F#01; 02; 17; 18.
- This component located at fabrication Bay#11.

AWS D1.5 2002 Section 3.7.5: "The Engineer shall be notified before improperly fitted and welded members are cut apart".

Approved Shop Drawing: "WSD1-TL5-4F-F".
